Staff Report: Z-61-18-8 September 28, 2018

Z-61-18-8 is a request to establish Historic Preservation (HP) overlay zoning for the property known historically as the Arizona Sash & Door Company Warehouse, located approximately 230 feet north of the northeast corner of 1st and Buchanan Streets [411 South 1st Street]. Maps and photos of the subject property are attached.

Z-61-18-8
Arizona Sash & Door Company Warehouse,
411 South 1st Street

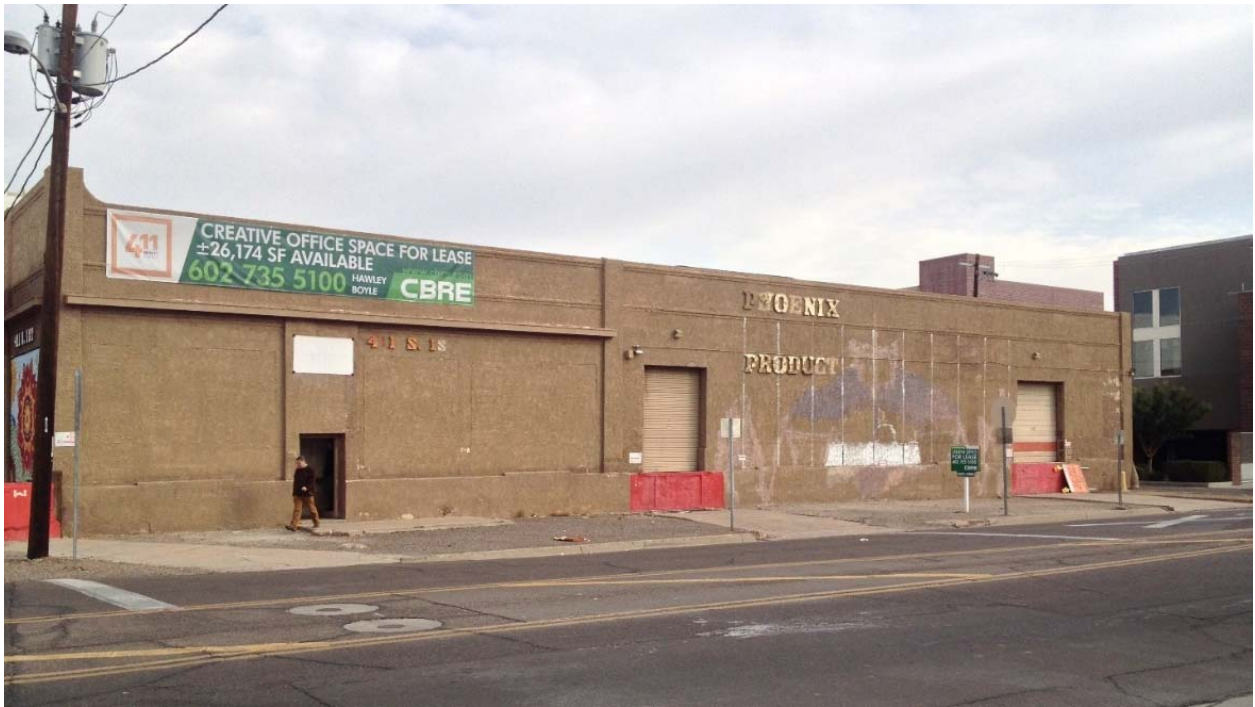
Photo 1. View of west façade of 411 South 1st Street depicting infilled windows and stucco sheathing, prior to rehabilitation, facing southeast (2016).

In December 2016, the City of Phoenix HP Office received a request from Brevoort Preservation Strategies on behalf of the property owner, 1st Buchanan, LLC, to establish HP overlay zoning for the subject property. The property had been previously evaluated for historic designation but was never recommended eligible because the original brick had been sheathed with stucco and the window openings had been filled in. However, staff learned that the original windows were still present and visible from the inside, and the owner began the process of removing the infill from the openings. On December 20, 2016, HP staff officially recommended the property eligible for HP zoning. The owner continued to rehabilitate the property, restoring the original steel windows, removing the stucco to expose the original brick, and making other improvements to convert the former warehouse to office use.

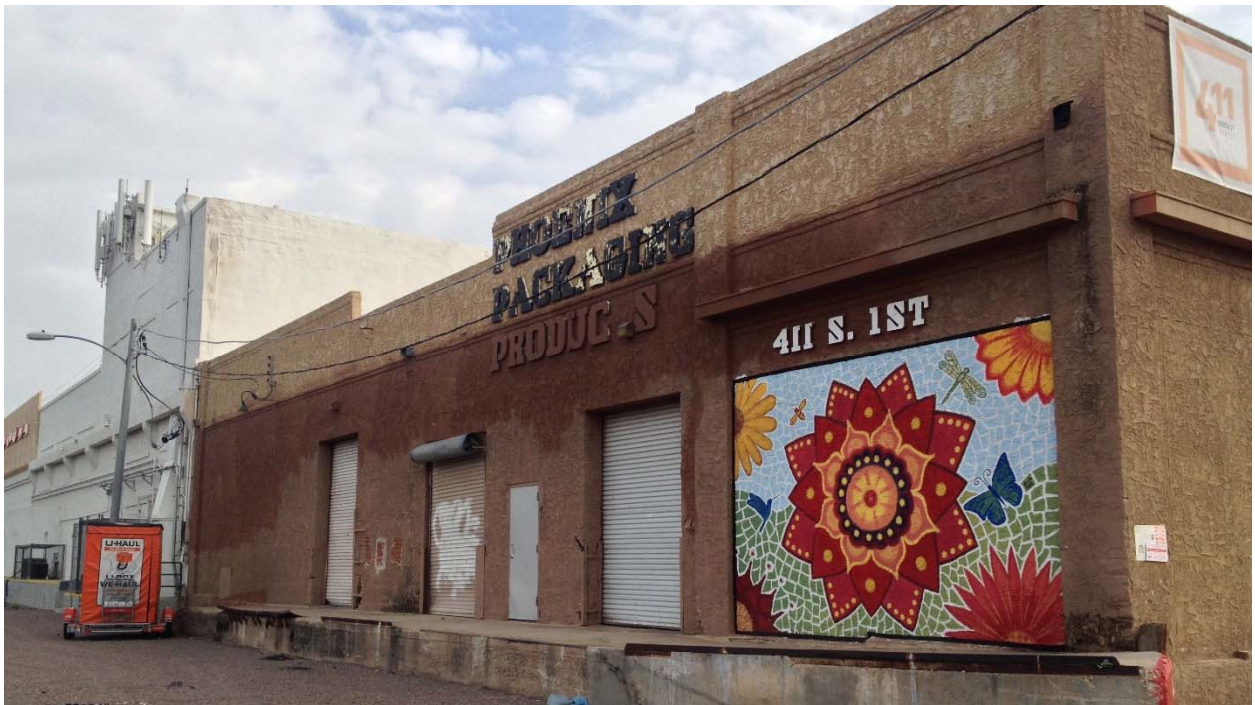
Photo 2. View of north façade prior to rehabilitation, facing southeast (2016).

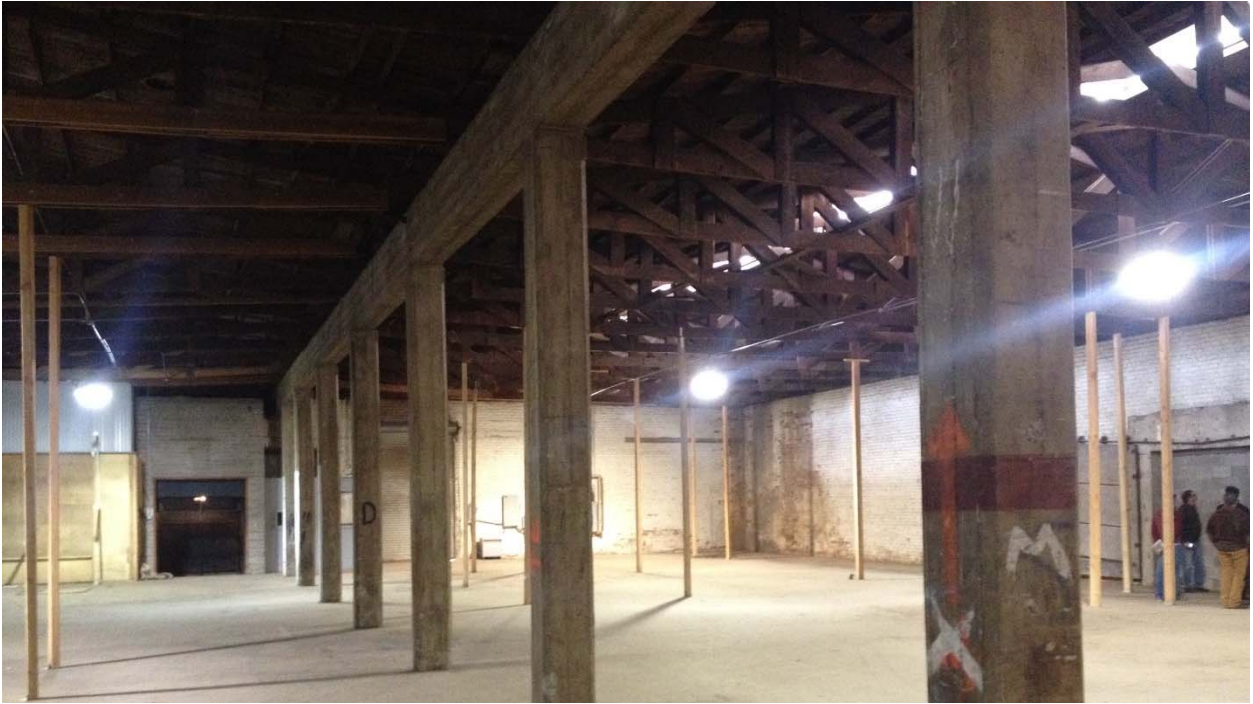
Photo 3. Interior view, prior to rehabilitation (2016).

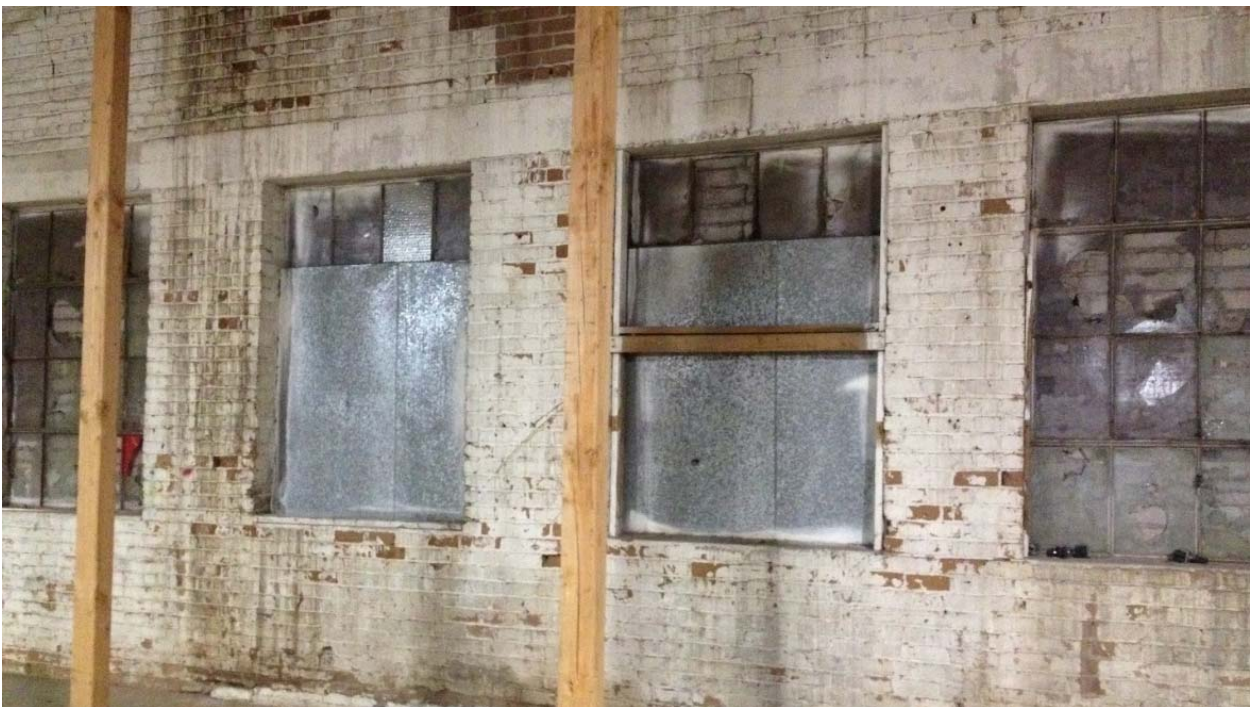
Photo 4. Infilled windows from interior, prior to rehabilitation (2016).

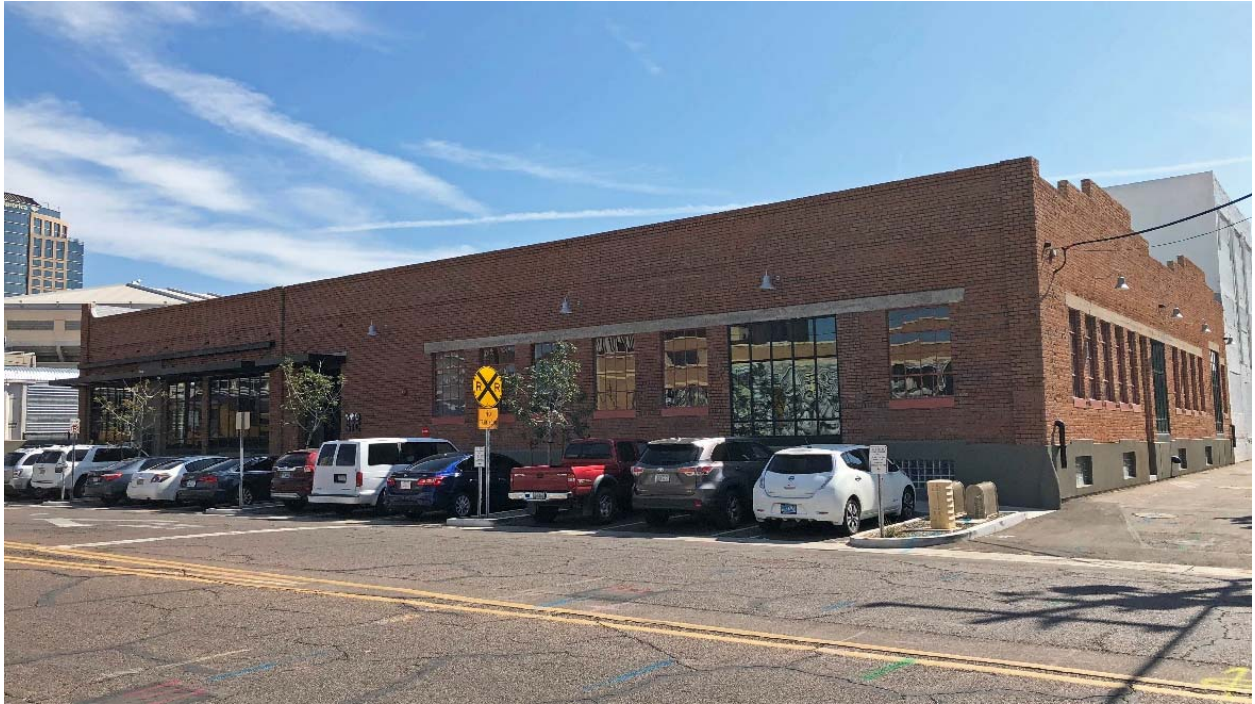
Photo 5. View of west façade after rehabilitation, facing northeast (2018).

The subject property meets the eligibility criteria for integrity. The building is still in its original location, adjacent to the railroad line, which is a key component of its significance. Although many historic buildings in the warehouse district have been lost, the industrial setting is still sufficiently intact to help convey the building’s significance. While previous alterations had adversely affected the building’s historic integrity, now that the rehabilitation has been completed, the building’s original design, materials and workmanship are evident once again.

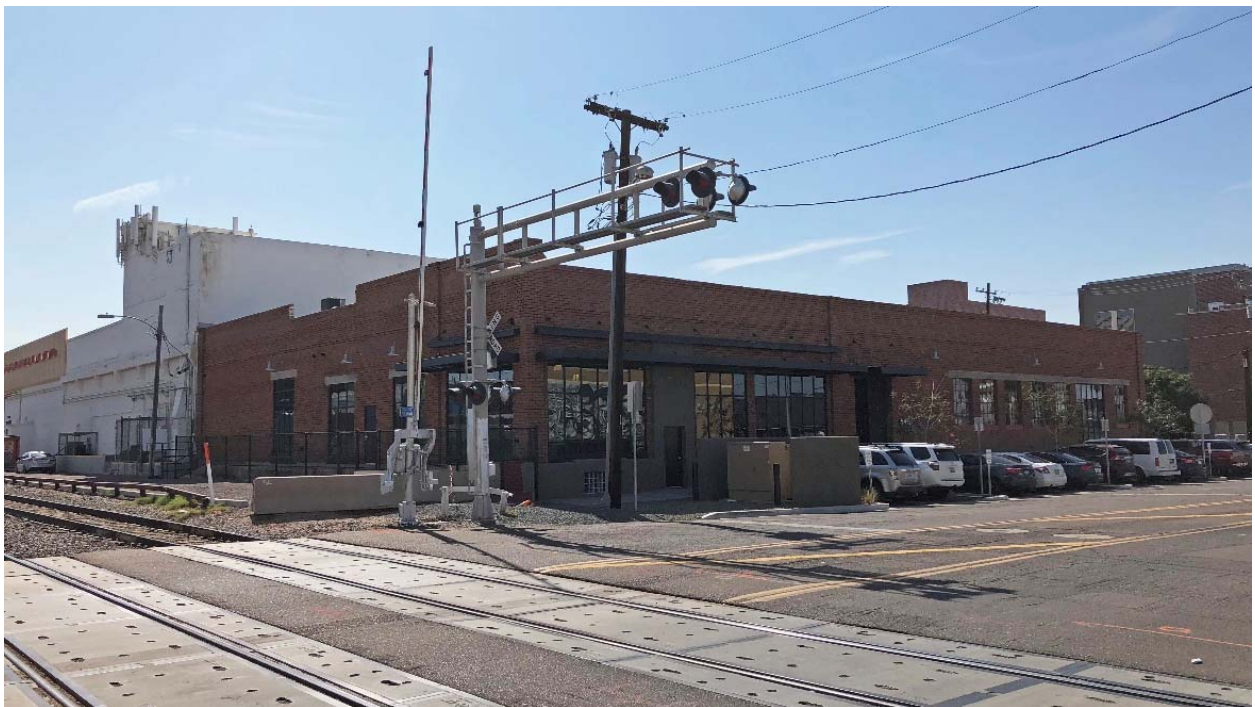
Photo 6. View of west façade after rehabilitation, facing southeast (2018).

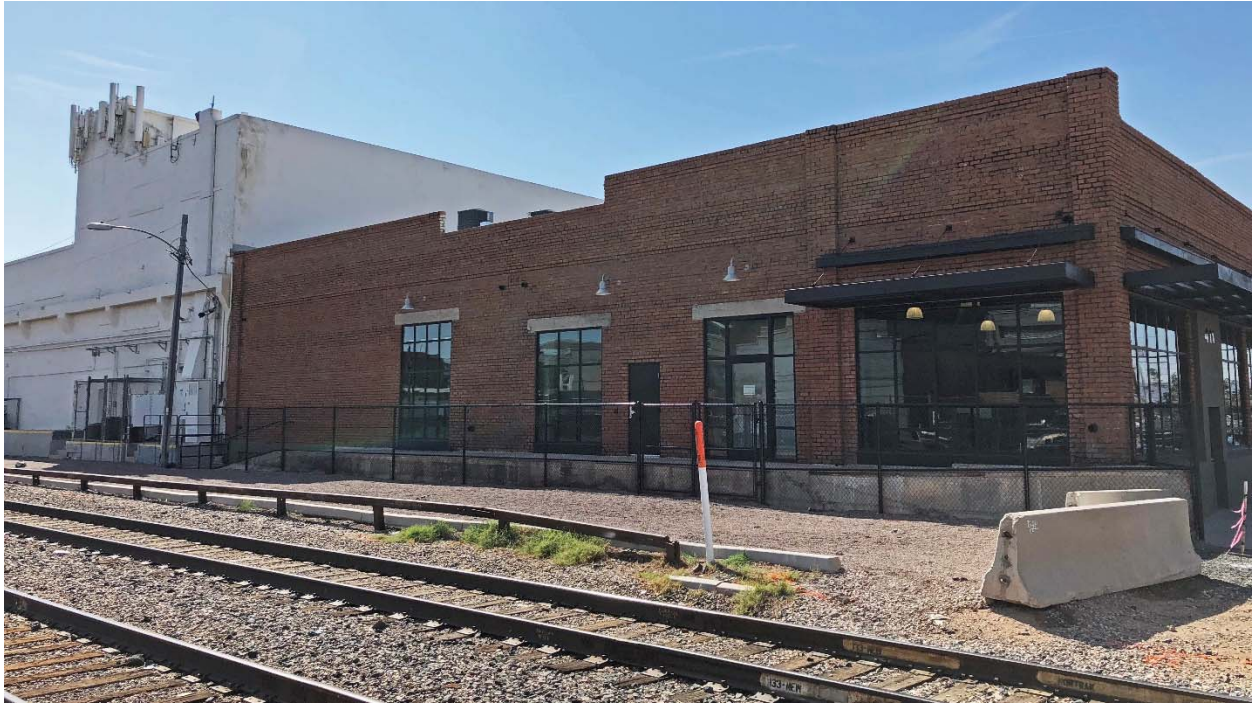
Photo 7. View of north façade after rehabilitation, facing southeast (2018).

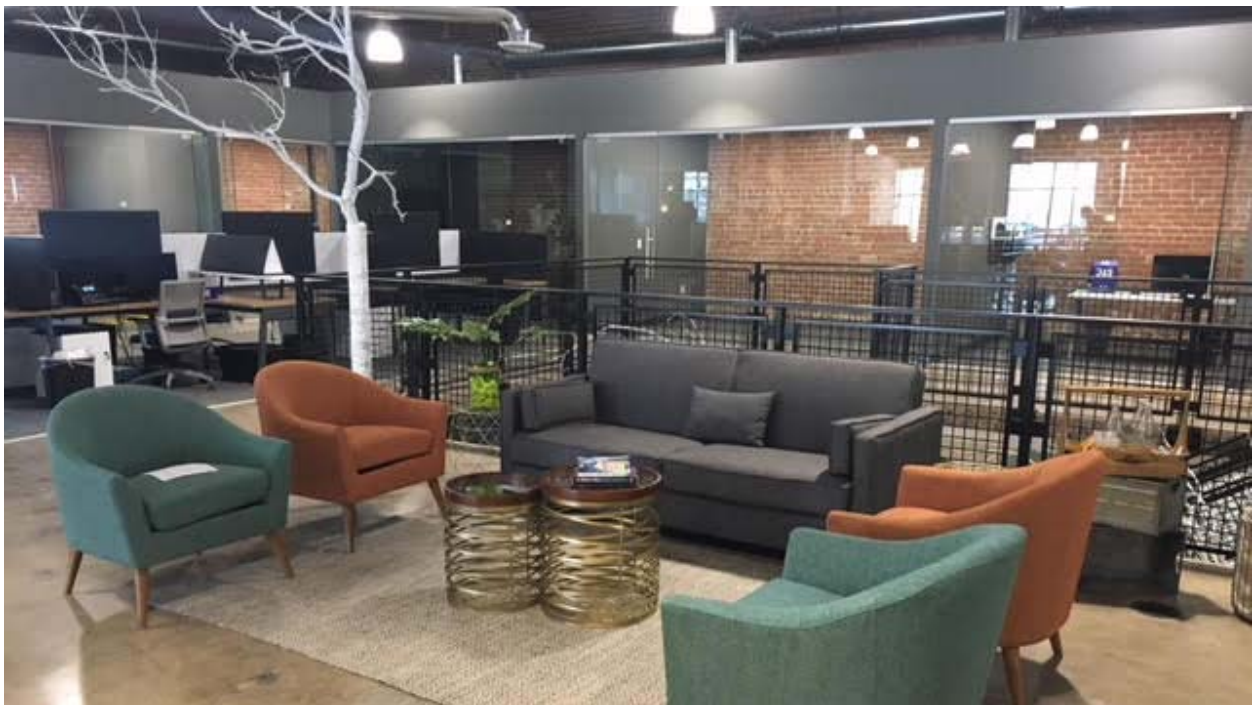
Photo 8. Interior view after rehabilitation (2018).
