PLANNING & DEVELOPMENT DEPARTMENT  
HISTORIC PRESERVATION OFFICE

### Staff Report: Z-61-18-8 September 28, 2018

Z-61-18-8 is a request to establish Historic Preservation (HP) overlay zoning for the property known historically as the Arizona Sash & Door Company Warehouse, located approximately 230 feet north of the northeast corner of 1<sup>st</sup> and Buchanan Streets [411 South 1<sup>st</sup> Street]. Maps and photos of the subject property are attached.

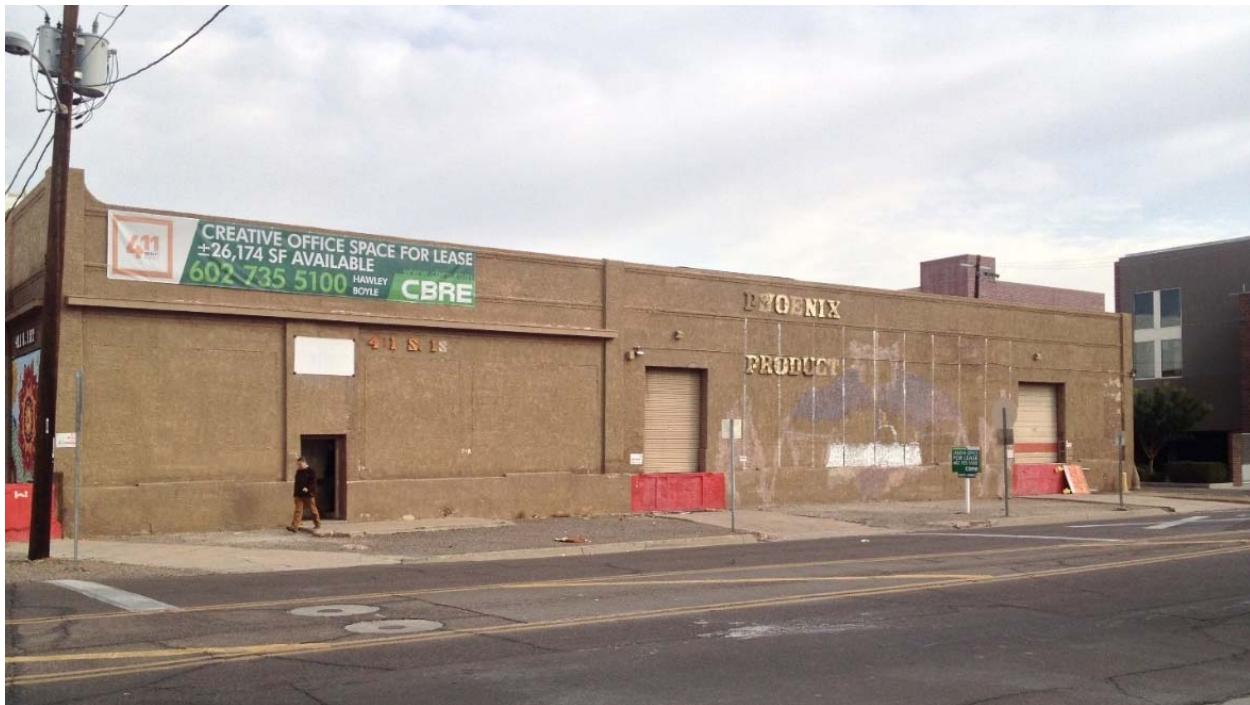
**Photo 1.** View of west façade of 411 South 1<sup>st</sup> Street depicting infilled windows and stucco sheathing, prior to rehabilitation, facing southeast (2016).

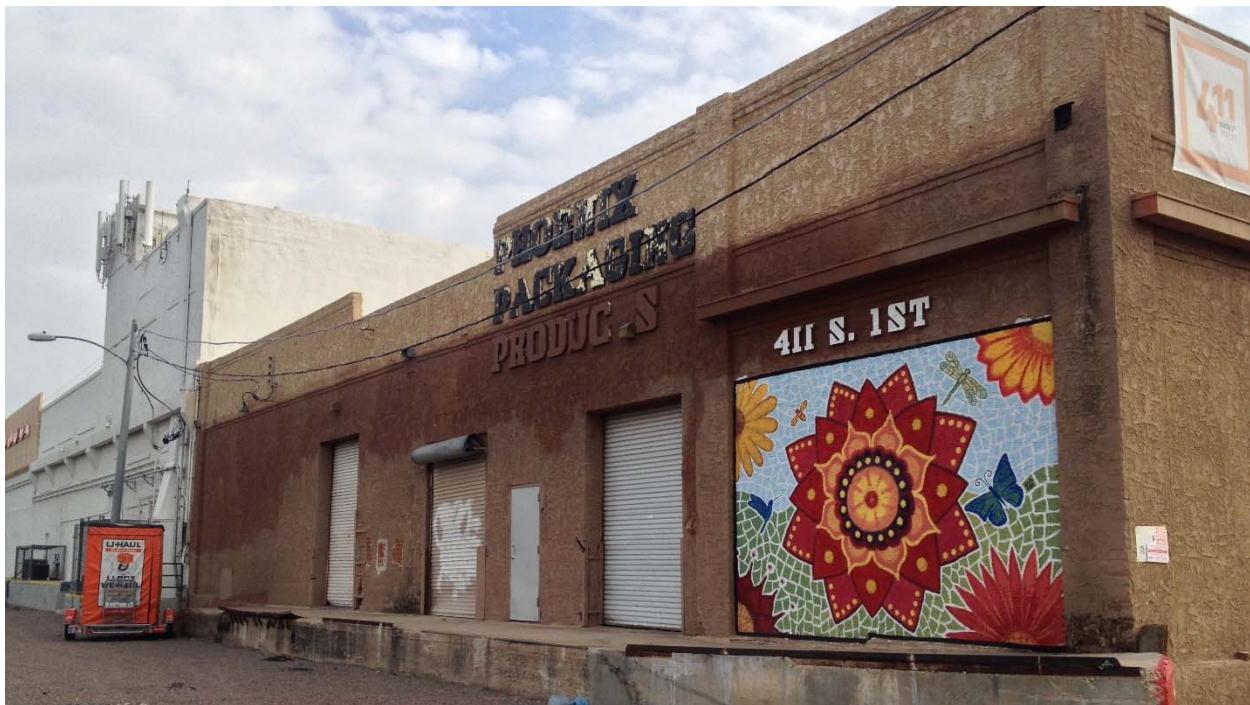
**Photo 2.** View of north façade prior to rehabilitation, facing southeast (2016).

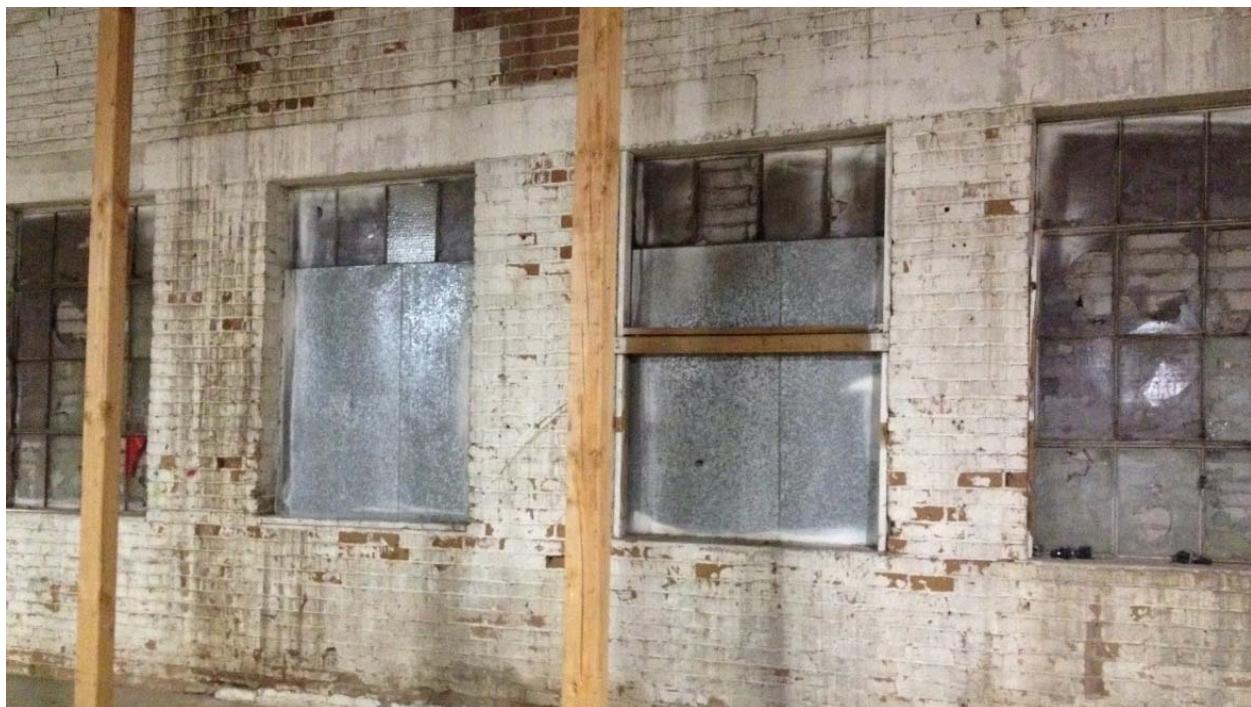
**Photo 4.** Infilled windows from interior, prior to rehabilitation (2016).

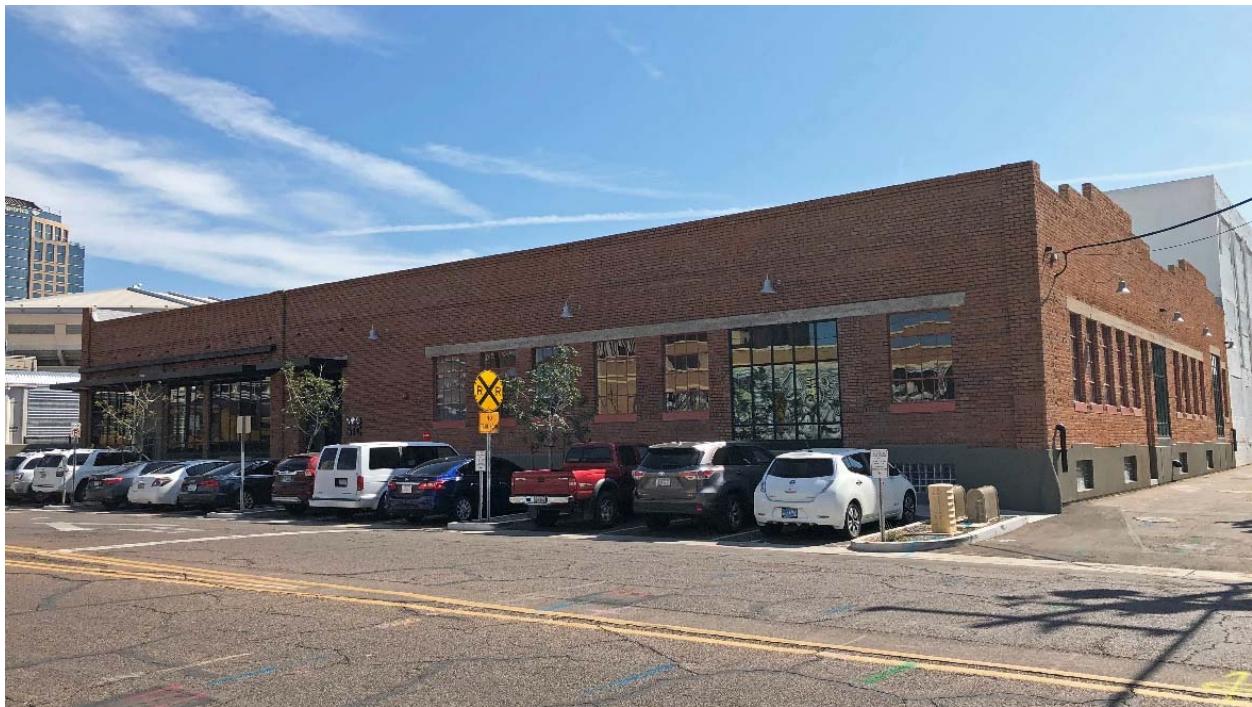
**Photo 5.** View of west façade after rehabilitation, facing northeast (2018).

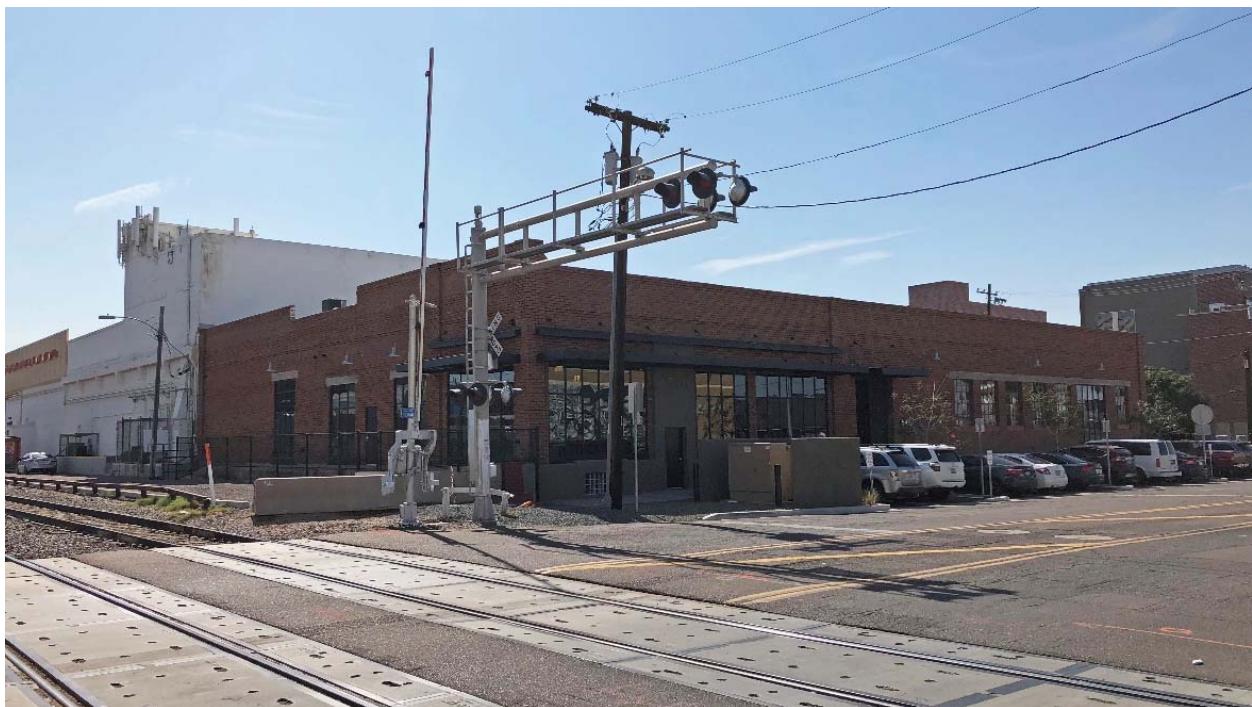
**Photo 6.** View of west façade after rehabilitation, facing southeast (2018).

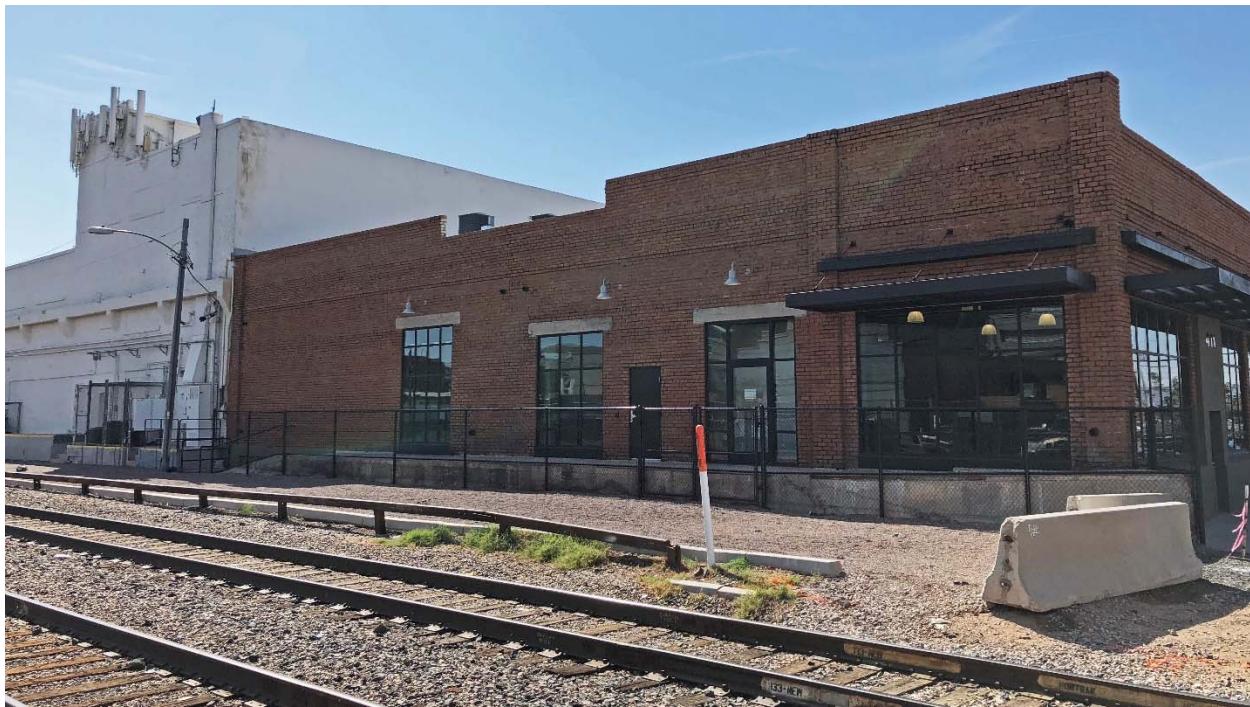
**Photo 7.** View of north façade after rehabilitation, facing southeast (2018).
