We are requesting support from the City of Phoenix Phil Gordon Threatened Building Grant Program for the stabilization, restoration, and long-term preservation of the Dr. J. Eugene and R. Thomasena Grigsby home located at 1117 North 9th Street in the North Garfield Historic District. The property consists of a relatively stable 1919 Craftsman bungalow purchased by the Grigsby family in the mid-1950s, as well as a permitted 1963 artist studio addition which features a stunning stained-glass window designed and built by Dr. Grigsby at the north studio entry door.

1117 N 9th Street Existing Conditions as of April 10, 2025

Dr. J. Eugene and R. Thomasena Grigsby House
Key to Exterior Windows and Doors

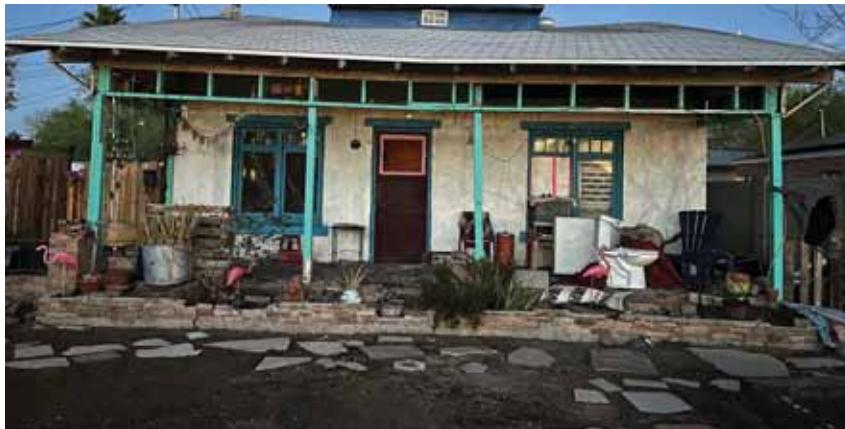
Front porch facade (view looking east). Glass has been removed from the front door and south porch window for installation of an air-conditioning unit. The toilet is on the front porch.

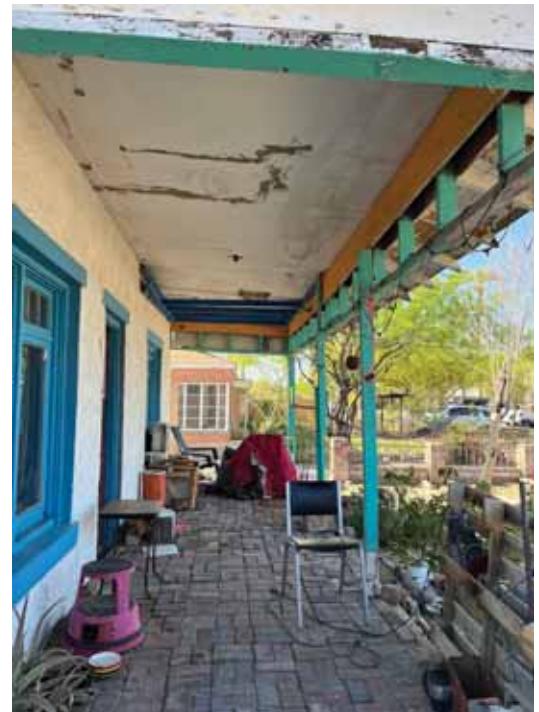
Detail of front porch (view looking south) showing layer of bricks on top of original concrete porch deck. Deficient spliced 2 x 4 porch supports, missing fascia, and damaged porch ceiling are also visible.

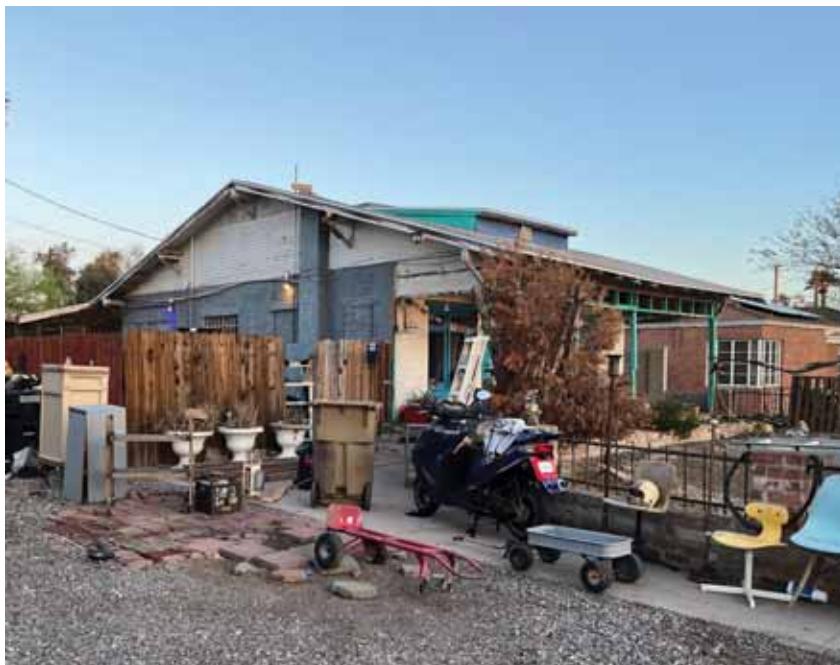
Front porch and north side yard (view looking southeast). Dead vegetation will be removed with stumps ground out, and cedar fencing which encloses the north side yard and obstructs the view of the north studio entry door will be removed.

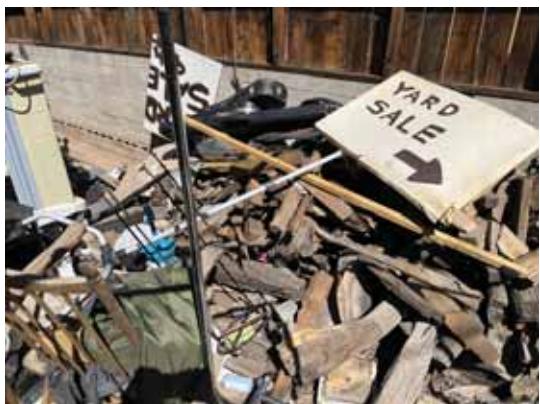
Wood and debris fire hazard in north enclosed side yard.

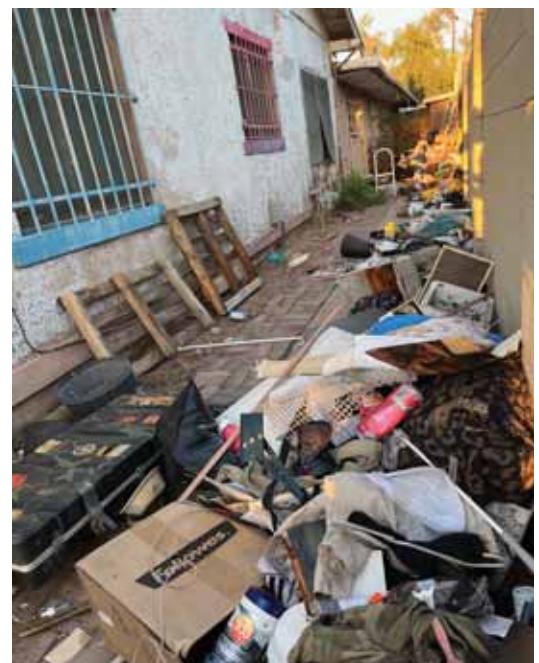
Side yard and 1963 studio addition (view looking east). Security bars will be removed from windows.

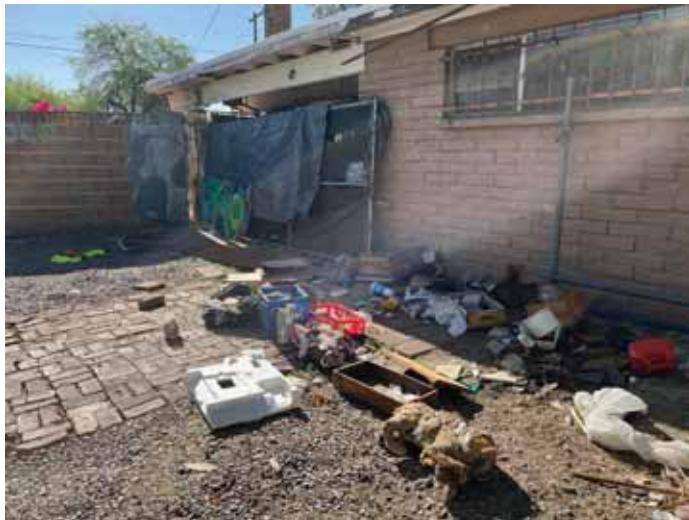
North studio exterior side yard (view looking east) where block wall has been removed and carport entrance where rolling gate has been disabled precluding use and access to covered parking.

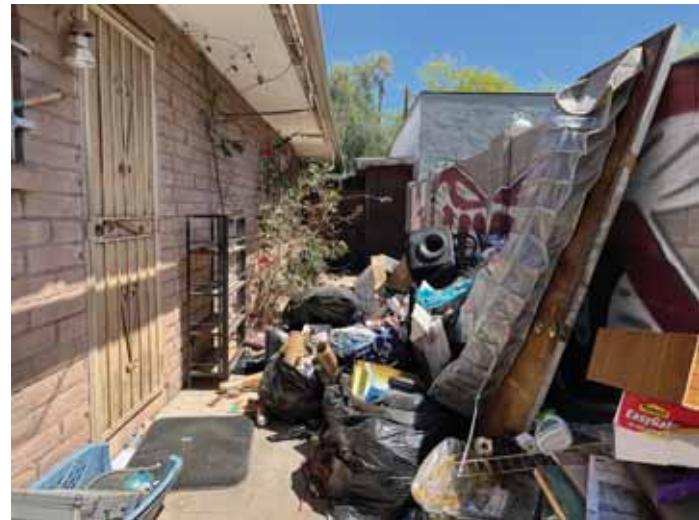
South studio side yard and south studio door (view looking east). Debris including filled cat litter boxes with swarms of flies, graffiti, and debris which blocked the use of the door.

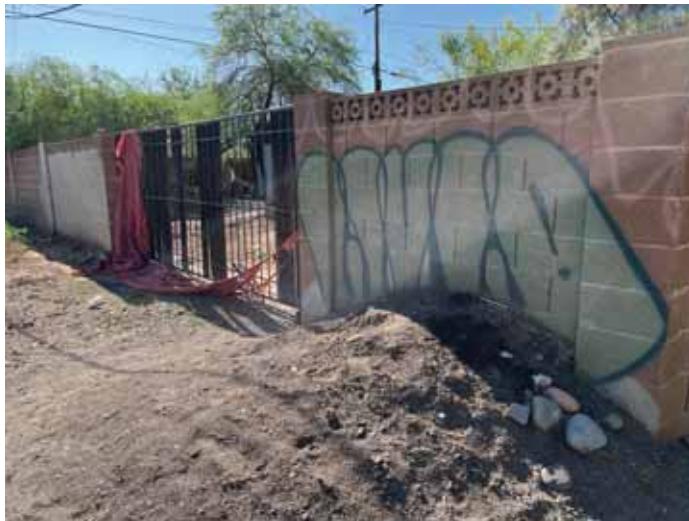
Exterior graffiti and mounding of soil, gravel, and debris to preclude vehicular access to the public alleyway (negatively impact neighboring properties on the north side of the alleyway) and inoperable rolling gate to the rear yard of the property (view looking southeast from the public alleyway).

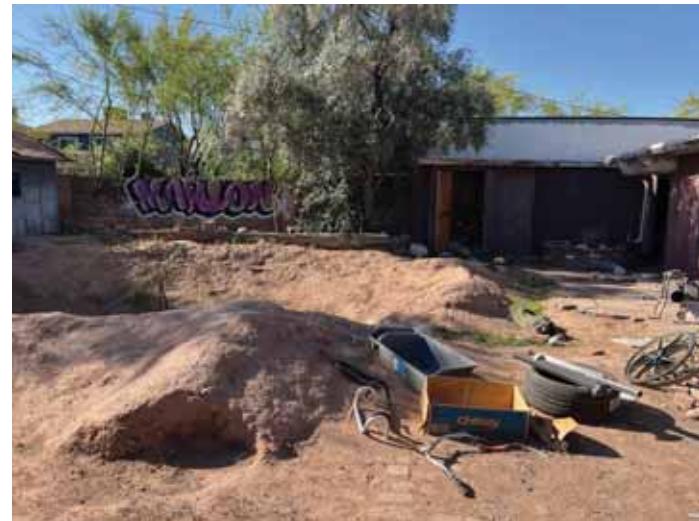
Exterior graffiti, debris, and a deep crater with mounding of soil, gravel, and debris in the rear yard (view looking south from north property line).

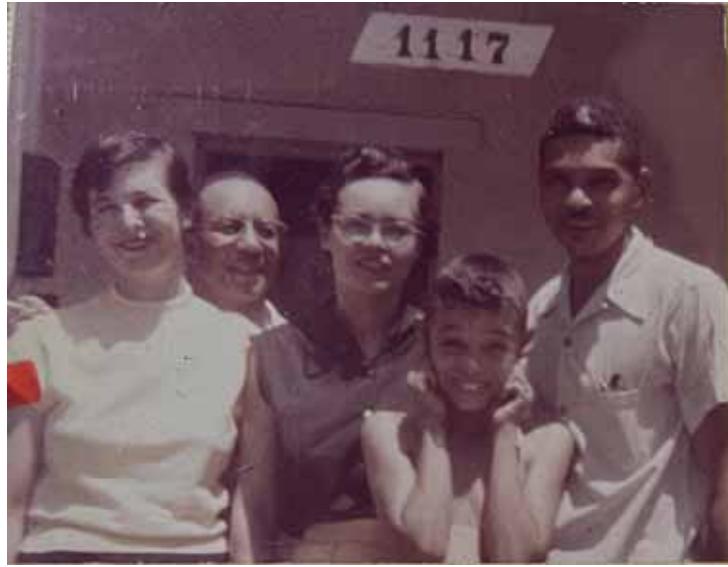
The first photograph found inside the property was taken prior to the 1957 porch enclosure. From left to right: Grigsby family friends Velma Howell and Gerald Howell from Memphis, TN, Rosalyn Thomasena Grigsby, Marshall Grigsby, and Dr. J. Eugene Grigsby. The house number, partial porch column, and lintel above the original front door are visible.

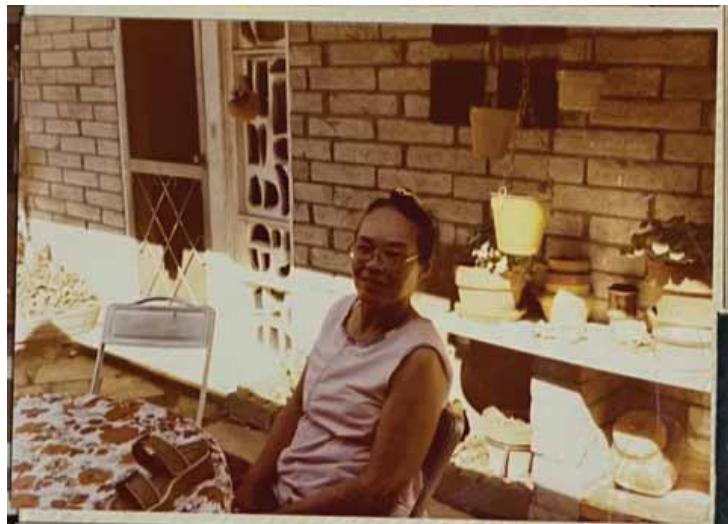
Rosalyn Thomasena Marshall Grigsby seated in the outdoor area in the north side yard outside of the 1963 studio addition. The stained glass sidelight next to the studio door is visible. This area was later enclosed by the Grigsby family.

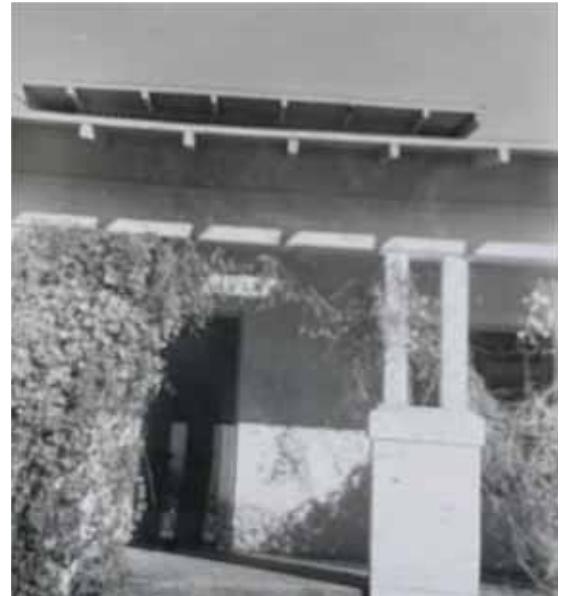
Another photograph found later inside the house shows the more ornate design of the original 1919 bungalow front porch columns as well as the original parameters and overhang eaves of the roof dormer.

Rebuild Front Porch Columns. The final design and construction of the front porch columns will replicate the design visible in the most recently discovered photograph of the pre-enclosure front porch circa 1956. Architectural plans and engineering will be developed from the photograph evidence and evaluated prior to permitting and construction.

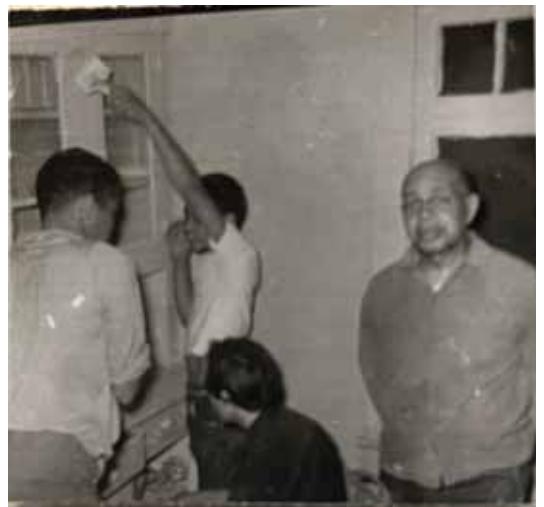
This photograph was taken shortly after the home was acquired from the probate court in the mid-1950s. The family is painting the original built-in hutch in the dining room of the 1919 bungalow. This hutch had been removed sometime in the past decade and will be restored as part of the scope of this renovation project. Left to right: Dr. J. Eugene Grigsby, Marshall Grigsby, Rosalyn Thomasena Marshall Grigsby, and Reverend Cephas. The divided light window is also visible.

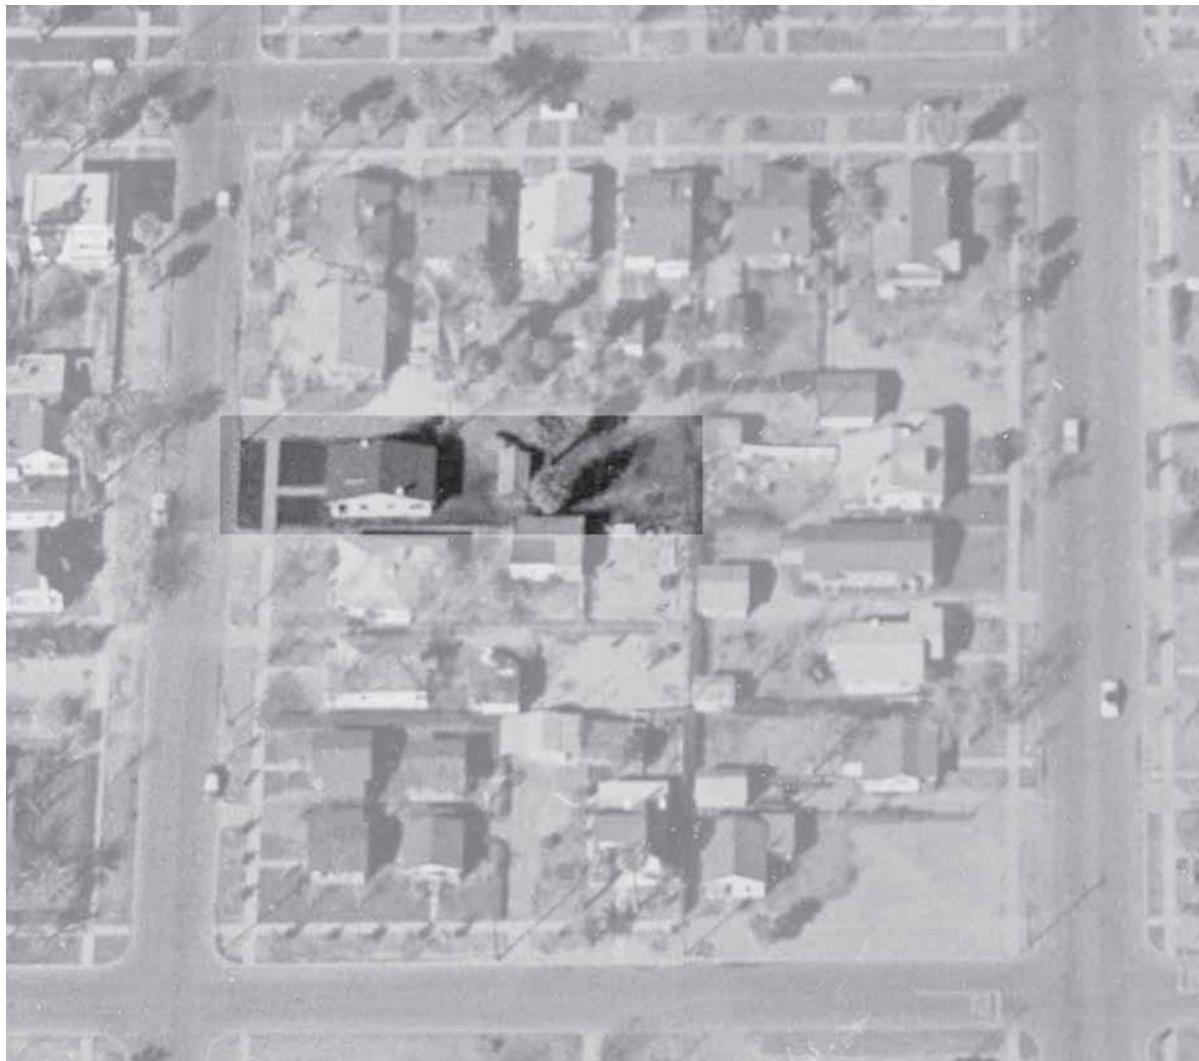
1117 N 9th Street Oblique Aerial View ca. 1957

The oblique aerial photograph shows the southwest front porch column, south facing windows, sidewalk from 9th Street to the front porch, and the original location of the metal-clad garage building which was later relocated to the east property line to make room for the 1963 studio addition.

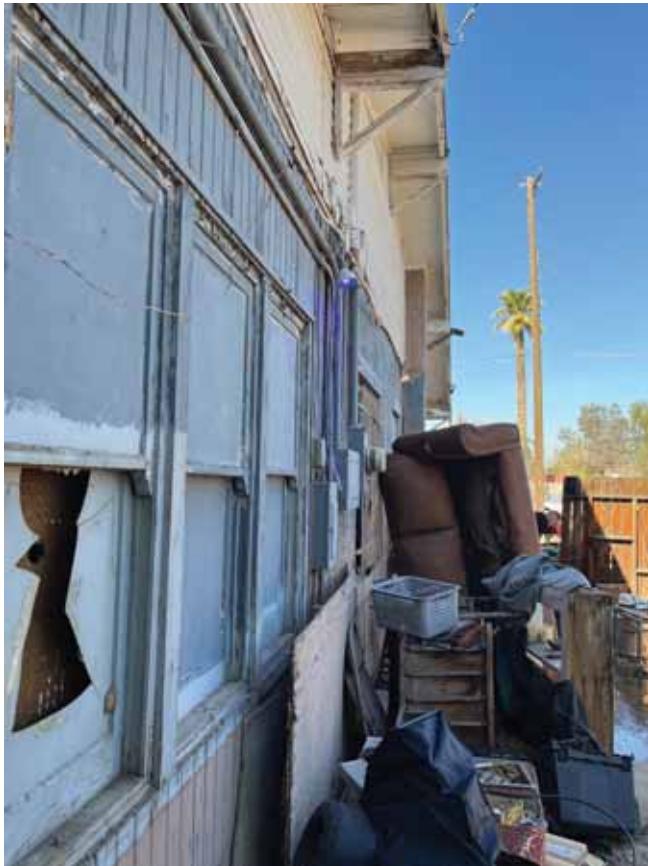
North studio side yard (view looking west) with furniture, cast iron tub left outside, broken sleeping porch window, furnishings, and debris. Some of Dr. Grigsby's artwork was scattered among the debris outside and consequently damaged.

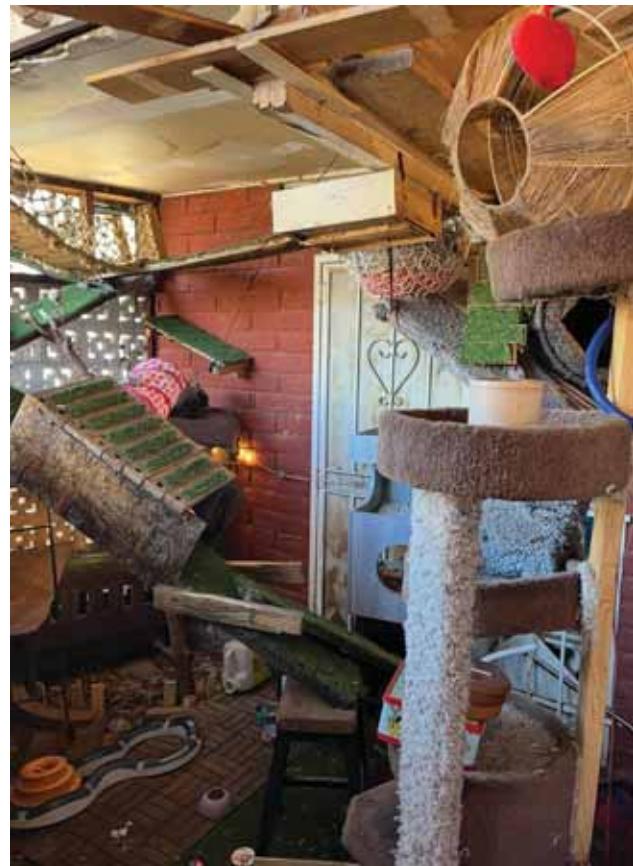
Adverse enclosure and complete obstruction of the north studio entry door and sidelight will be removed.

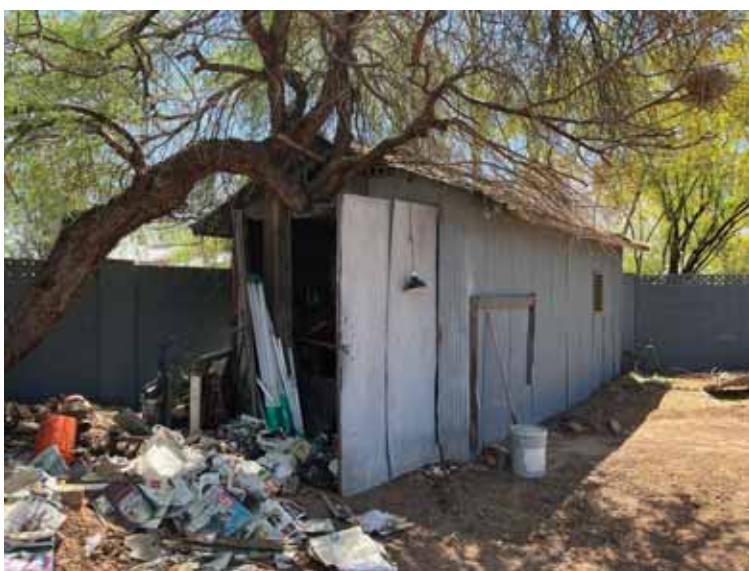
This metal-clad garage building was relocated to the east property line to make room for the 1963 studio addition. The building served as an art studio for Dr. Grigsby. This building will be rehabilitated as part of this project.

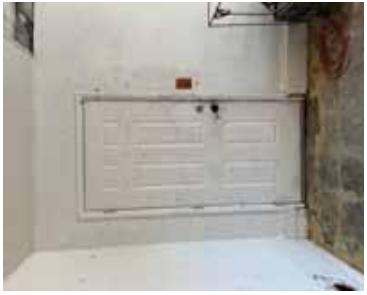
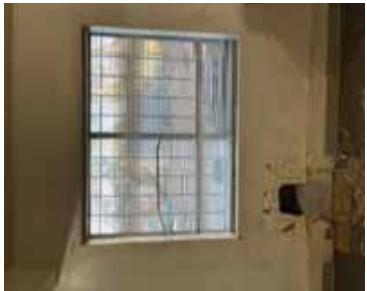
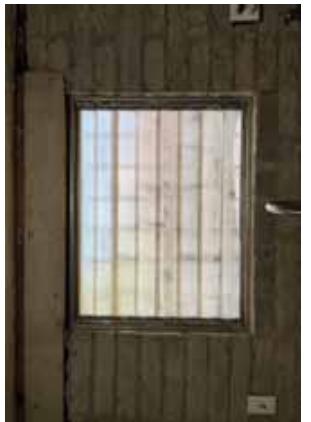
<p>3</p>	<p>4</p>	<p>5</p>

<p>Badly damaged original door. To be replaced with new Pella smooth-face door. Security screen door to be removed.</p> <p>80" x 32"</p>

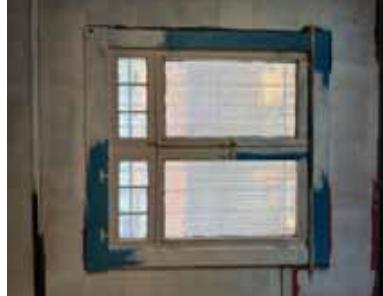
<p>Original hinged divided light window, sash, casing, and frame to be fully restored. Hinged inswing. Security bars and aluminum screen to be removed. New historic exterior window screen to be installed.</p> <p>54" x 49.5"</p>

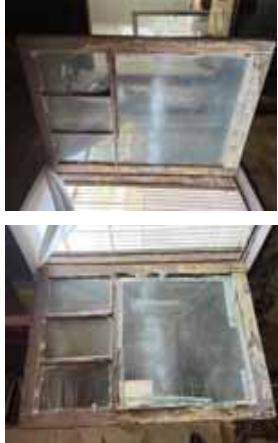
<p>Original hinged divided light window, sash, casing, and frame to be fully restored. Glazing currently held in place with duct tape. Hinged inswing. Security bars and aluminum screen to be removed. New historic exterior window screen to be installed.</p> <p>36" x 50"</p>

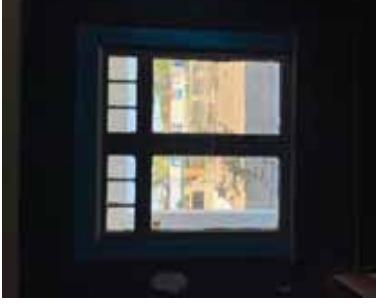
<p>This window opening had been bricked in on the outside and covered with a mantel shelf on the inside. The interior shelving was carefully constructed and reversible to preserve the window which still has the original glazing from 1919. The exterior wood requires restoration. LH hinged.</p> <p>29.5" x 24"</p>

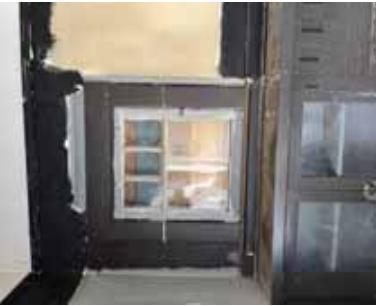
<p>This window opening is covered by plywood on the outside and was covered with a mantel shelf on the inside. Wires from a security system had been drilled through the window and window frame. The window requires restoration and new glazing in two of four panes. RH hinged.</p> <p>29.5" x 24"</p>
