ATTACHMENT B

Happy Valley Road: 67th Avenue to 35th Avenue Section from Final Technical Memorandum

Ludden Mountain

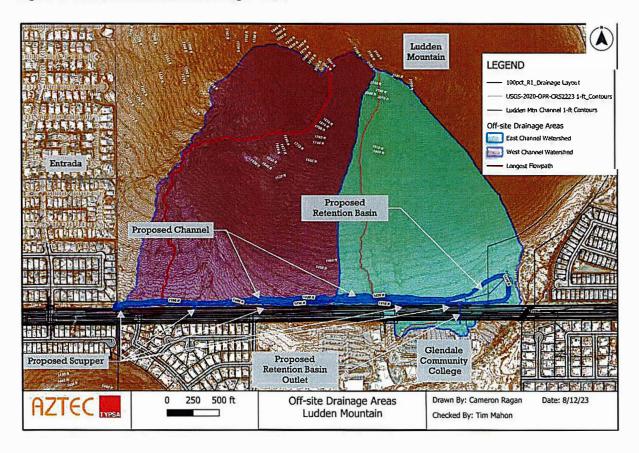
The purple and blue shapes show the drainage areas that would impact the project limits. In the existing condition, the flow from the blue drainage area ponds up on the north side of HVR during low flow events. While the purple drainage area runoff will flow along the shoulder of HVR towards the Entrada subdivision drainage channel. During high flow events, the cross slope of HVR at this location allows for the runoff to sheet flow across the road and be collected by existing scuppers on the eastbound curb of HVR. These scuppers outfall into the GCCN retention basins that will drain to channel system south and east of the site. Any drainage areas west of the purple shape will be collected by a concrete drainage ditch running from north to south along the edge of the development and will not impact this site. Any drainage areas east of the blue shape will be collected by the existing channel that flows towards the culvert crossing underneath HVR.

Figure 1: Ludden Mountain Drainage Areas

Ludden Mountain is located north of HVR across the road from GCCN between 62nd Avenue to the west and 55th Avenue to the east. The drainage areas were delineated using 2-ft contours received from the Flood Control District of Maricopa County (FCDMC). See Figure 1 below for a visual of the drainage areas and flow paths in this area.

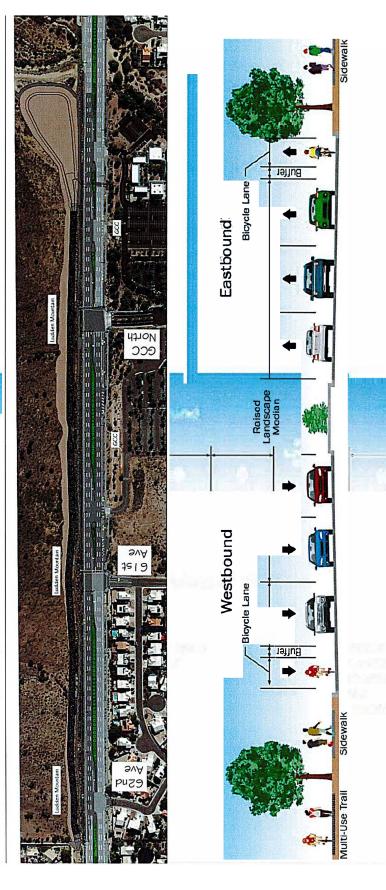
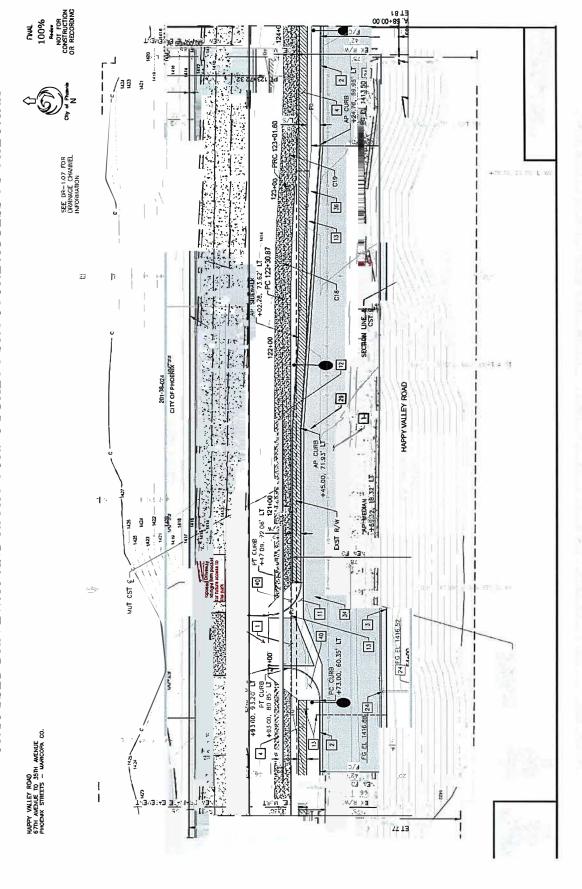
EXHIBIT C

Section: 62nd Ave. to West of 55th Ave.

PROPOSED DRIVEWAY AND RIGHT TURN POCKET FOR FUTURE ACCESS TO THE PARK
