**7's Reverse Lane Study  
7th Street and 7th Avenue  
from McDowell Road to Dunlap Avenue**

**Technical Memorandum**

Project No. ST89340552-1

**December 2021**

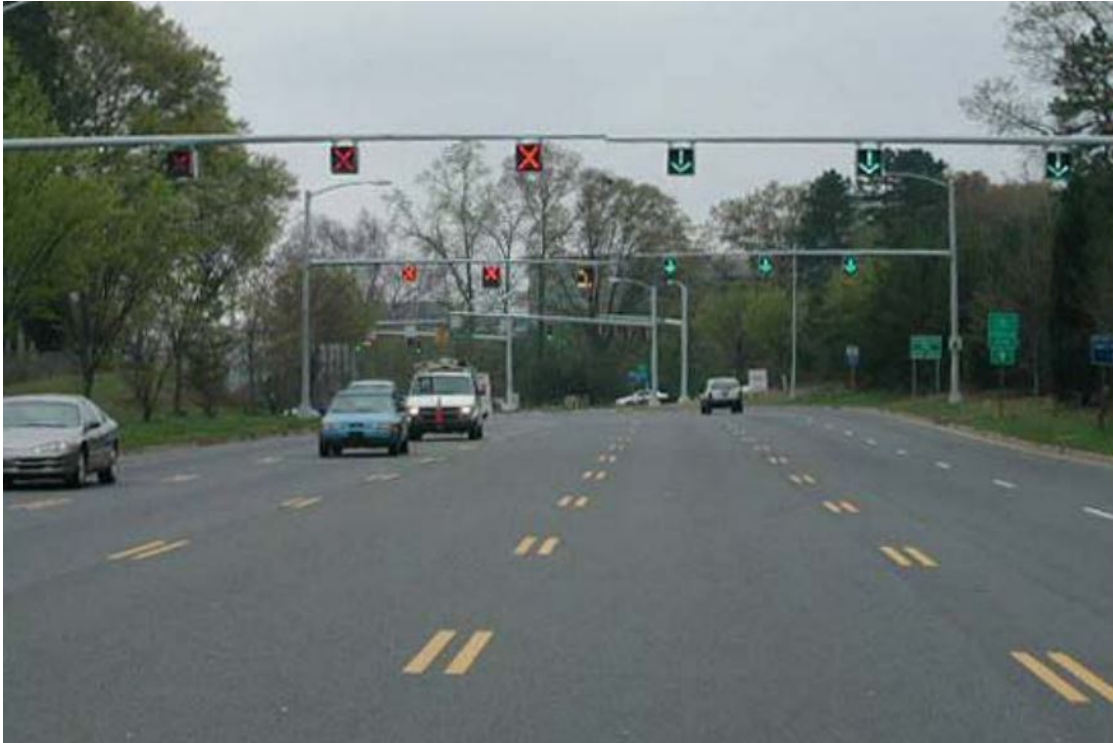
The reversible lanes system was implemented prior to the Charlotte Coliseum opening in 1987 but was rebuilt in 1998 and is used to accommodate the traffic demand associated with special events. A five-lane road was constructed with three reversible lanes so that four lanes could be used before and after events. It uses overhead signals in order to direct traffic at the coliseum for traffic to flow more smoothly. It is considered one of the most technologically sophisticated systems in the United States. Obtained from the 2000 NCHRP Synthesis 340: Convertible Roadways and Lanes, **Figure 5** displays the dynamic lane control signs placed on overhead mast arms within the corridor.

**Figure 5 – Reversible Lane on Tyvola Road, Charlotte, NC**

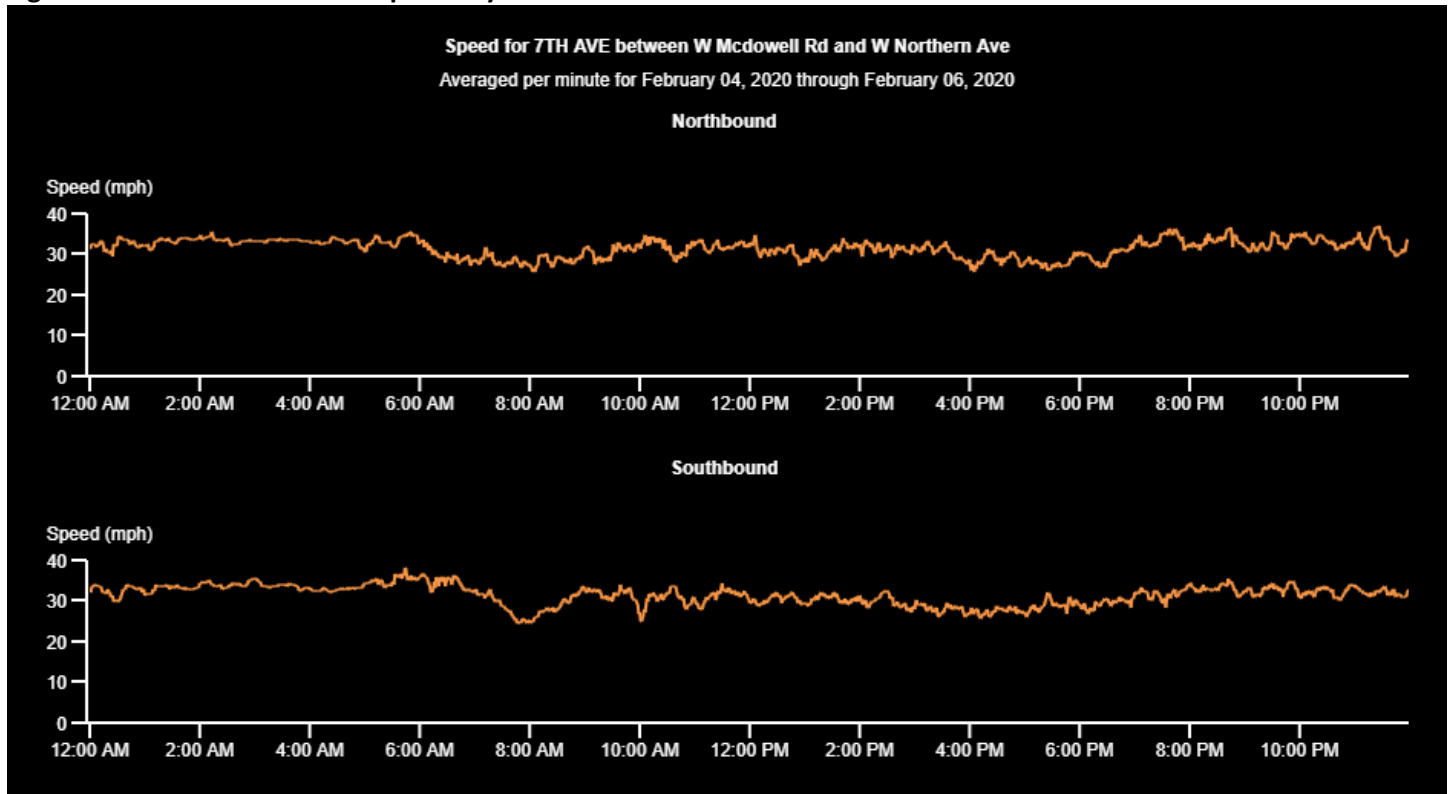
Figure 11 – 7th Avenue Travel Speeds by Direction of Travel

The corridor experiences two traditional peaks representing commuter traffic and a mid-day peak representing commercial traffic. Historic data, prior to the shelter-in home orders, was examined from the INRIX database for 7th Avenue. The posted speed limited along 7th Avenue is 35 mph from McDowell Road to Missouri Avenue and 40 mph from Missouri Avenue to Northern Avenue. The travel speeds by time and direction of travel are shown in **Figure 11**. The graphs depict the average speed during a 24-hour typical weekday case. As shown, the speeds are generally less than that of the posted speed even during off-peak hours possibly due to narrow lanes and side street friction. In both the northbound and southbound directions, there is a notable travel speed reduction in both peak periods. The travel time by time and direction of travel are shown in **Figure 12** and the planning time by time and direction of travel are shown in **Figure 13**. The decrease in travel speeds along 7th Avenue causes an increase in travel time and planning time. In the northbound direction, there is an increase in travel and planning time during both peak periods. In the southbound direction, there is also a notable increase in travel and planning time in both peak periods.

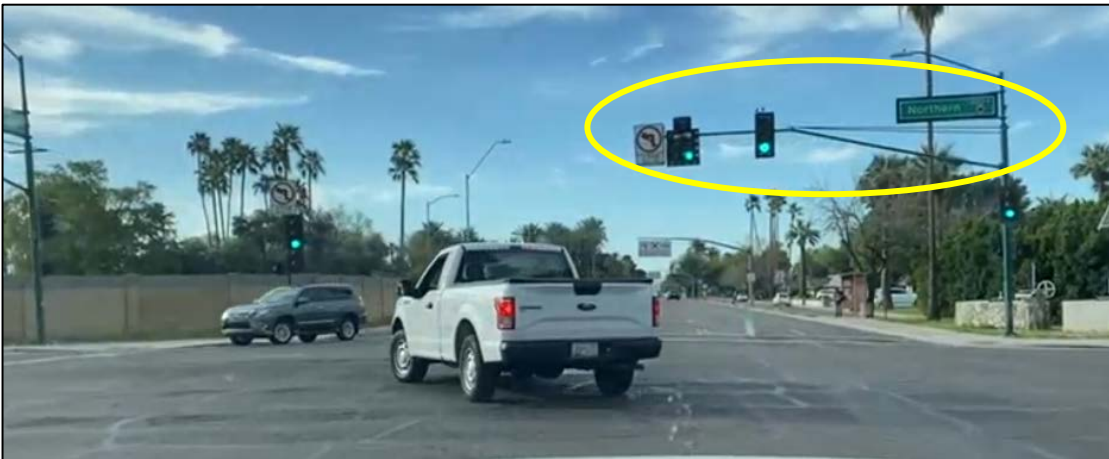
Photo 1 – Driver Turning Left at Northern Avenue During AM Peak (Static No Left-Turn Sign Visible)

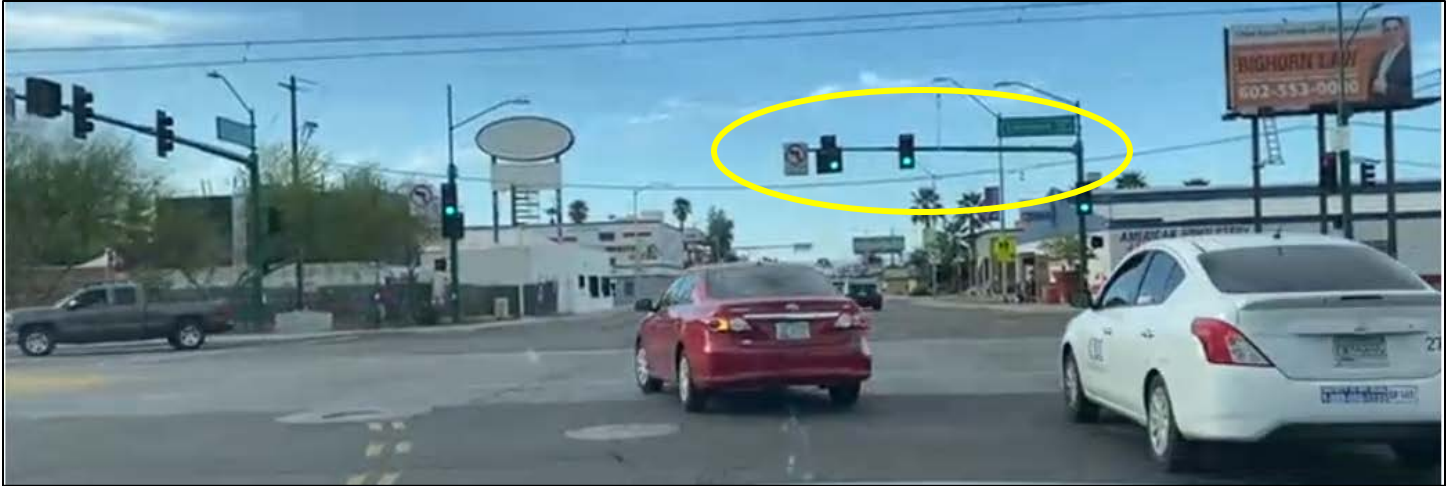
Photo 2 – Driver Turning Left at Camelback Road During PM Peak (No Left-Turn Sign Visible)

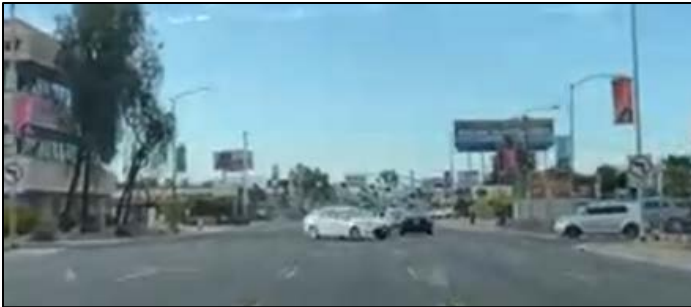
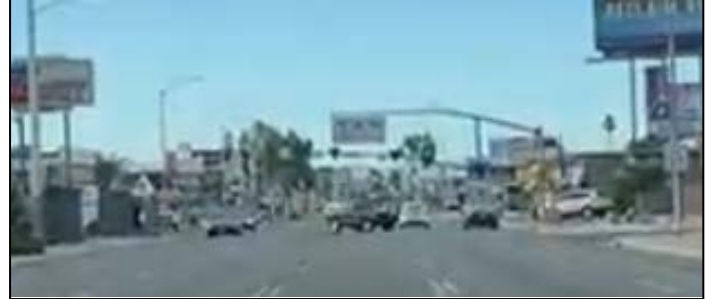
Photo 3 and Photo 4 – Driver Turning Left from Opposing Through Lane

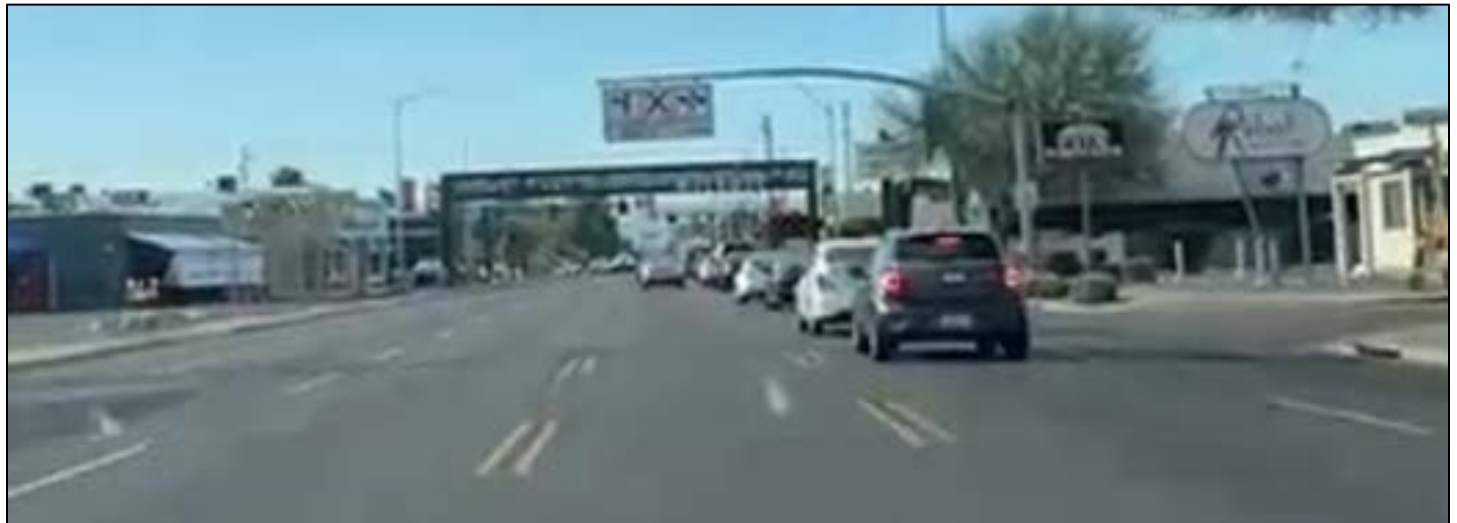
Photo 5 – Queueing in Adjacent Through Lanes Approaching Indian School Road (Southbound)

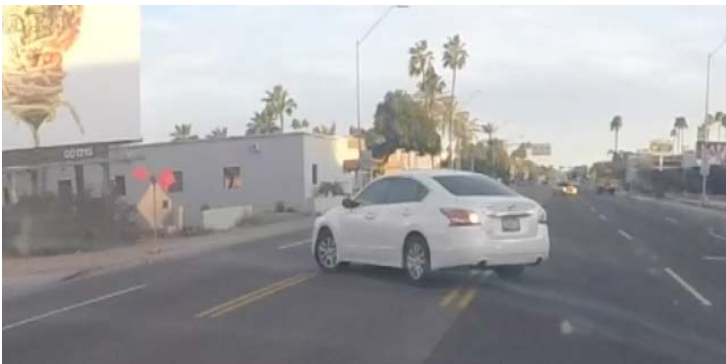
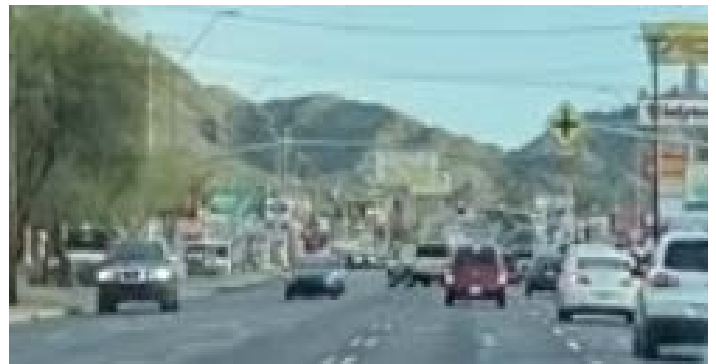
Photo 6 – Driver Turning Left from Opposing Through Lane (Northbound)

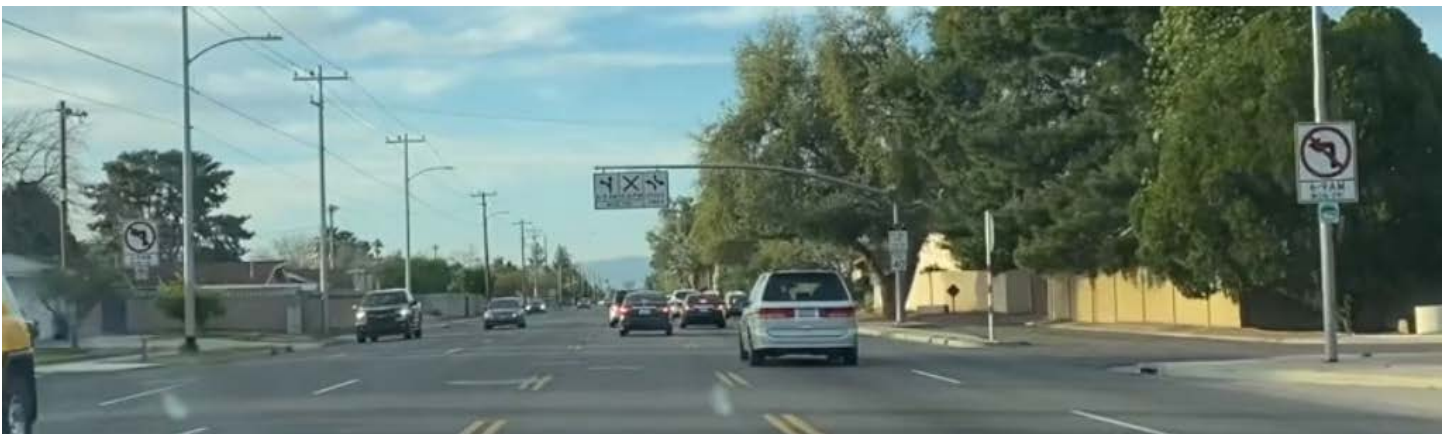
Photo 7 – Conflicting Signage at Winter Drive (Southbound)

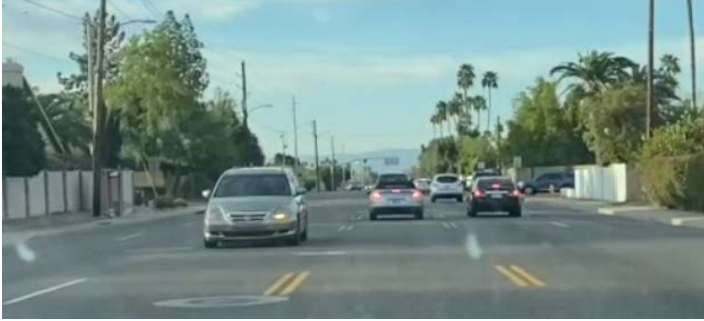
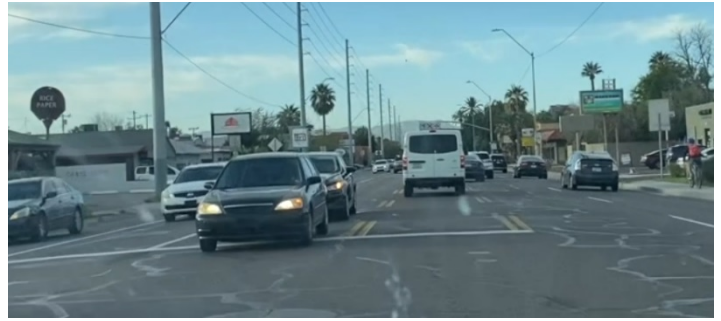
**Photo 8 – Driver Turning Left from Opposing Through Lane (Southbound)**

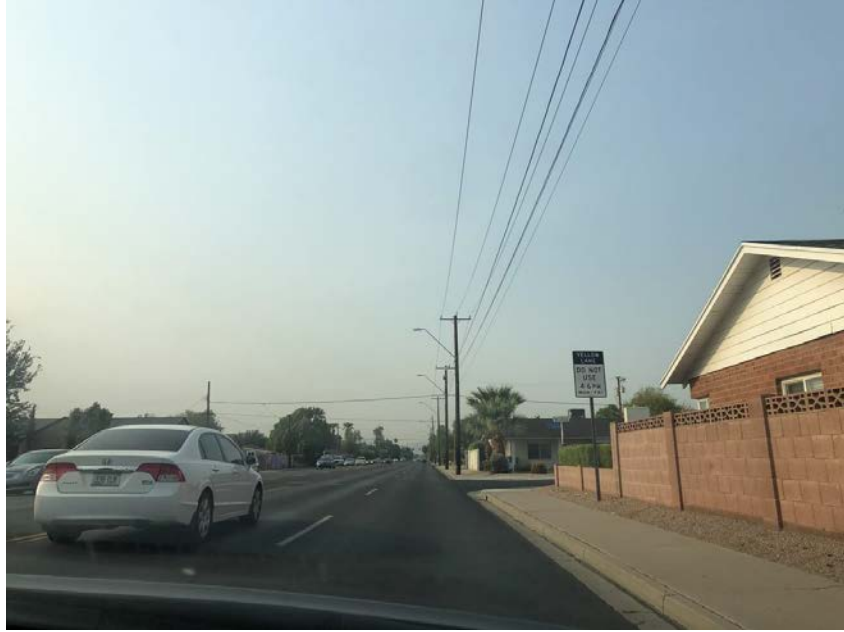
**Photo 9 – Southbound on 7th Avenue between Encanto Boulevard and Thomas Road:  
Overhead Power Pole in Sidewalk**

- *Street Fixtures:* “Where insufficient *public right-of-way* is available to locate street fixtures outside the 60 inch (1525mm) minimum clear width, the pedestrian access route may be reduced to 48 inches (1220mm) for a length of 24 inches (610mm) maximum, provided that reduced width segments are separated by segments of the pedestrian access route that are 60 inches (1525mm) minimum in length and 60 inches (1525mm) minimum in width.”

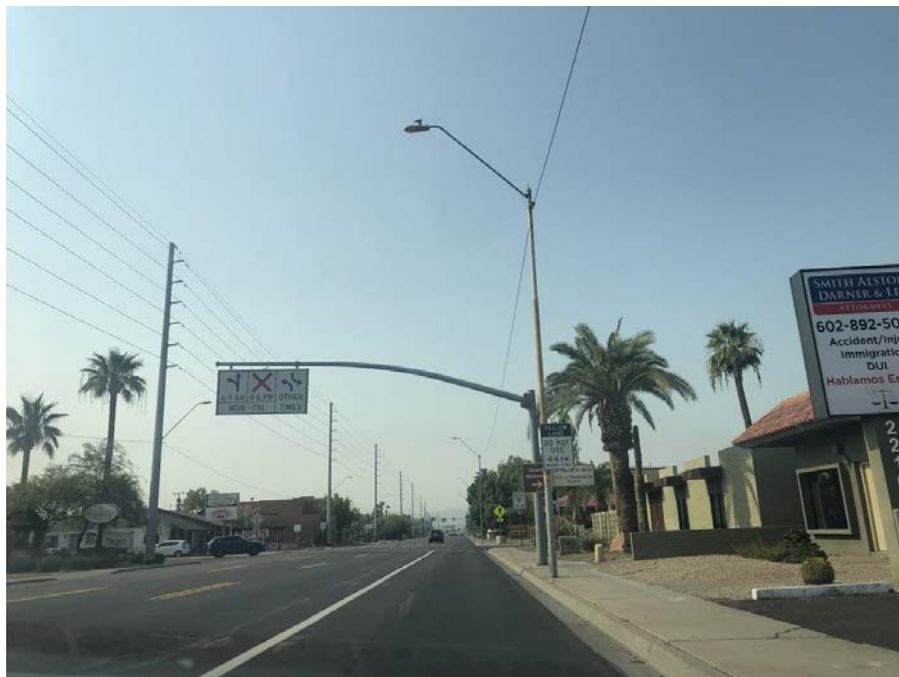
**Photo 10 – Northbound on 7th Street between Palm Lane to Virginia Avenue: Pole in Sidewalk**

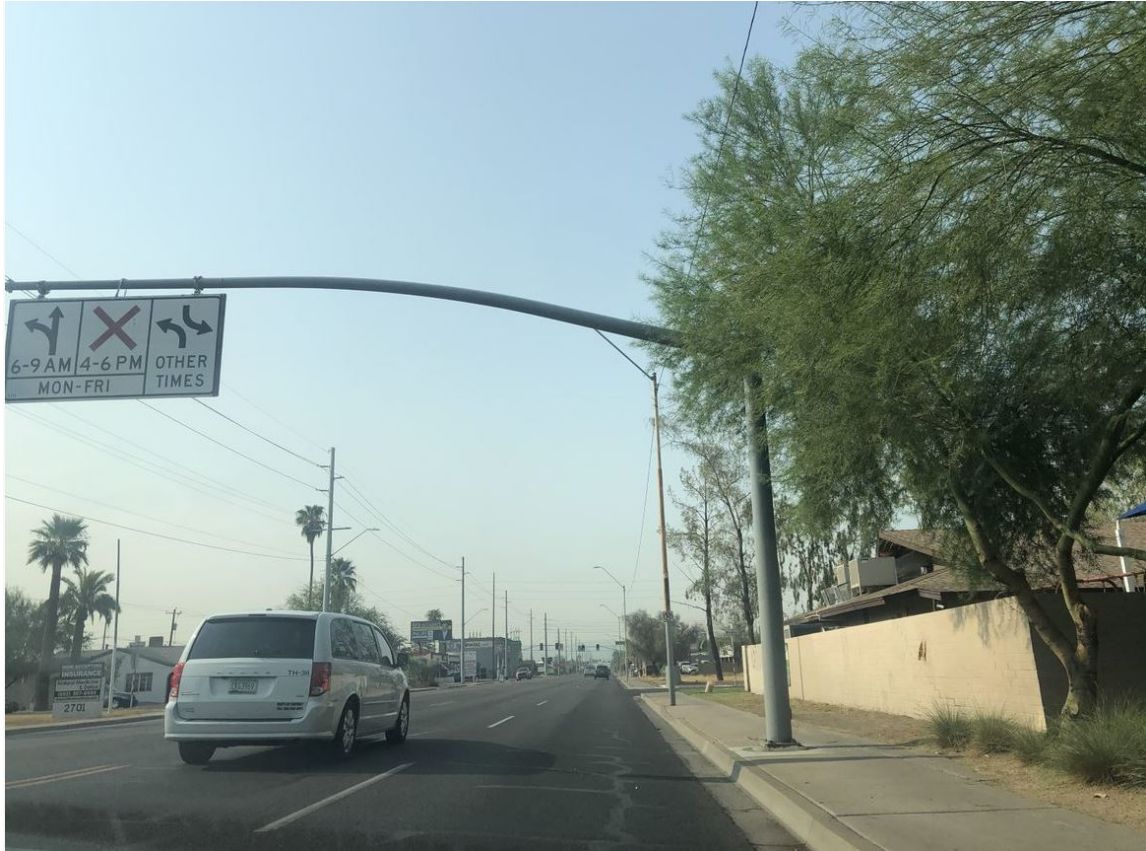
**Photo 11 – Southbound on 7th Street between Virginia Avenue to Thomas Road: Pole in Sidewalk**

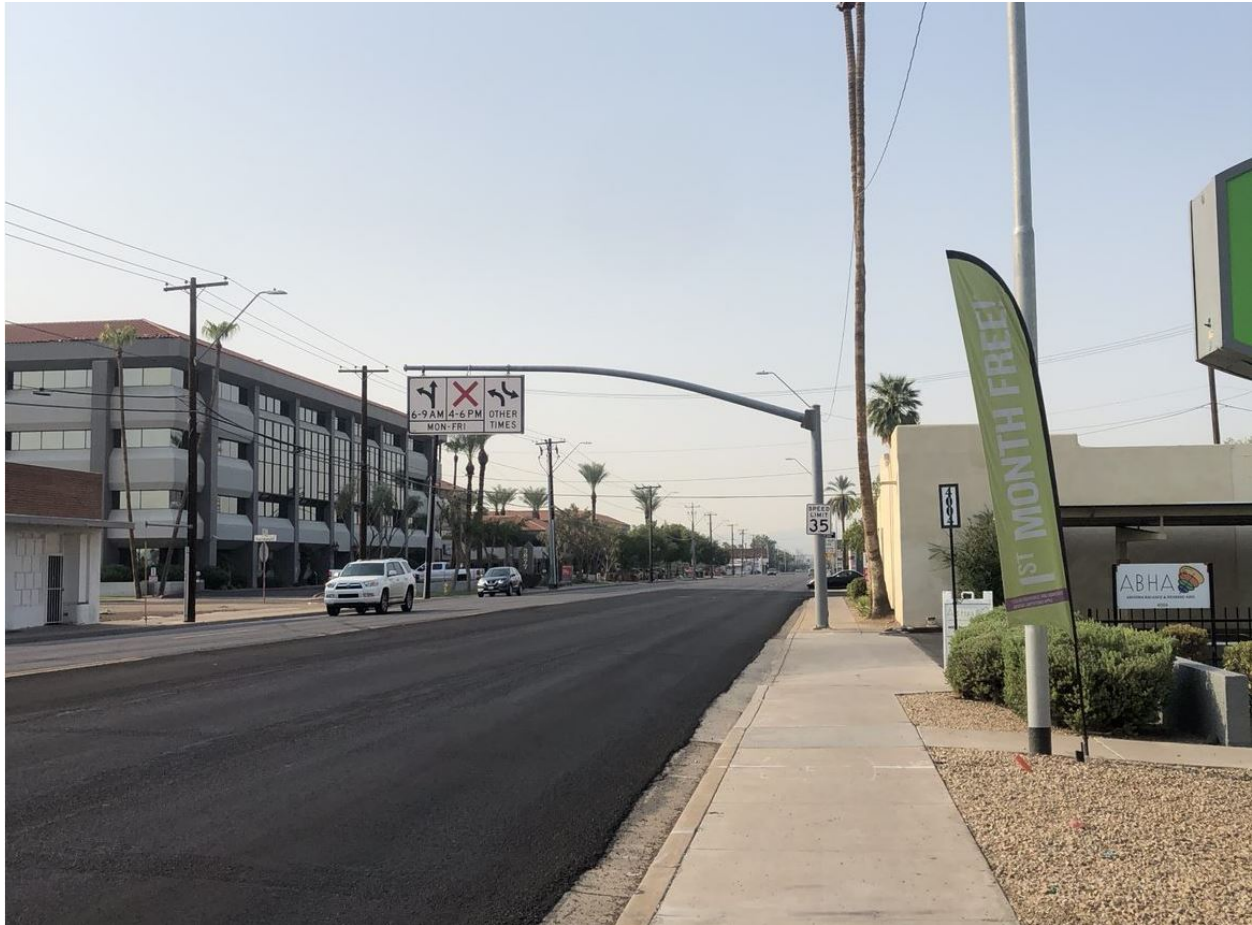
Photo 12 – Southbound on 7th Street between Indian School Road and the VA Med Center: Pole in Sidewalk

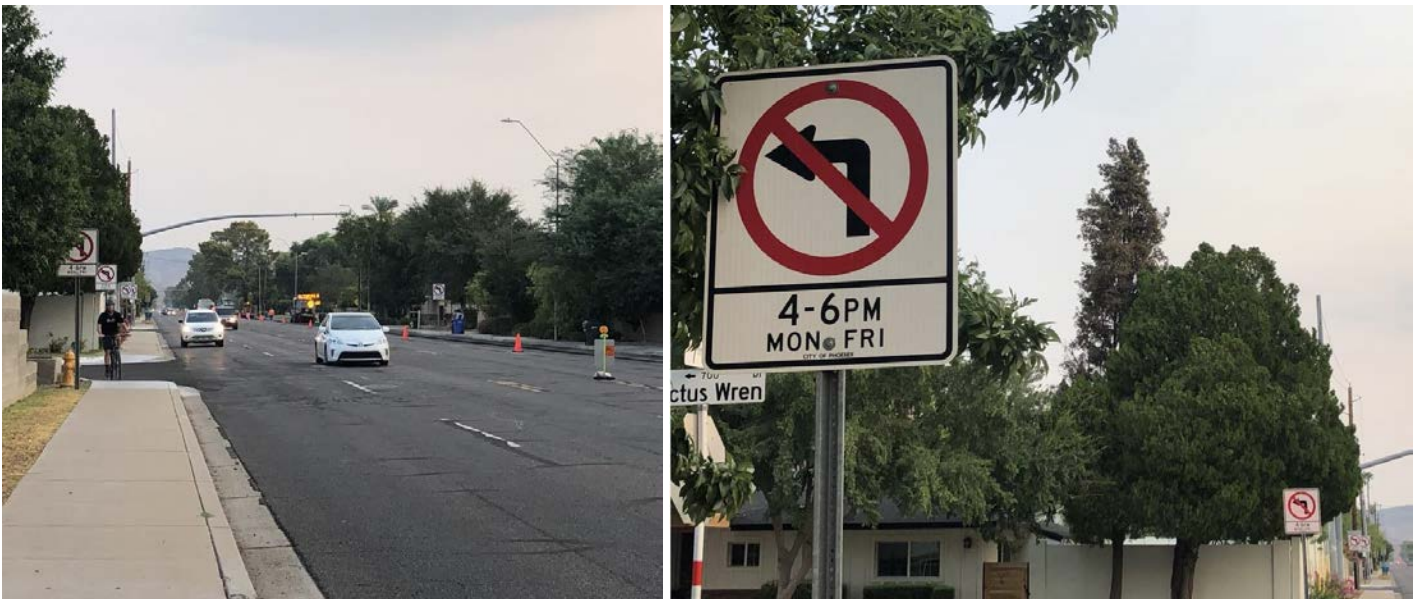
**Photo 13 – Northbound on 7th Avenue between Glendale Avenue and Northern Avenue:  
Several Left Turn Prohibited Signs**

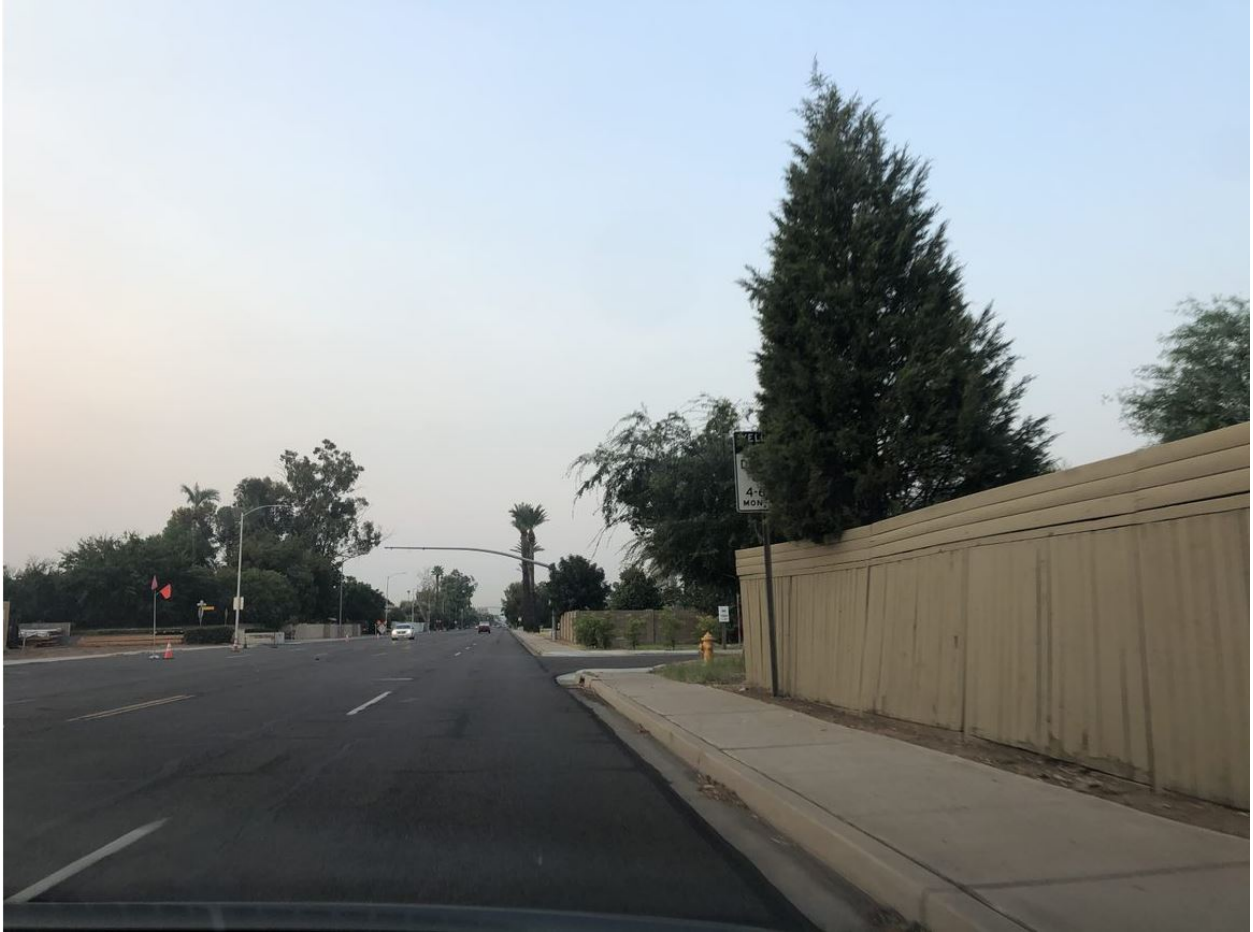
**Photo 14 – Southbound on 7th Avenue between Glendale Avenue and Maryland Avenue:  
Landscape Obstructing Reversible Lane Static Sign**

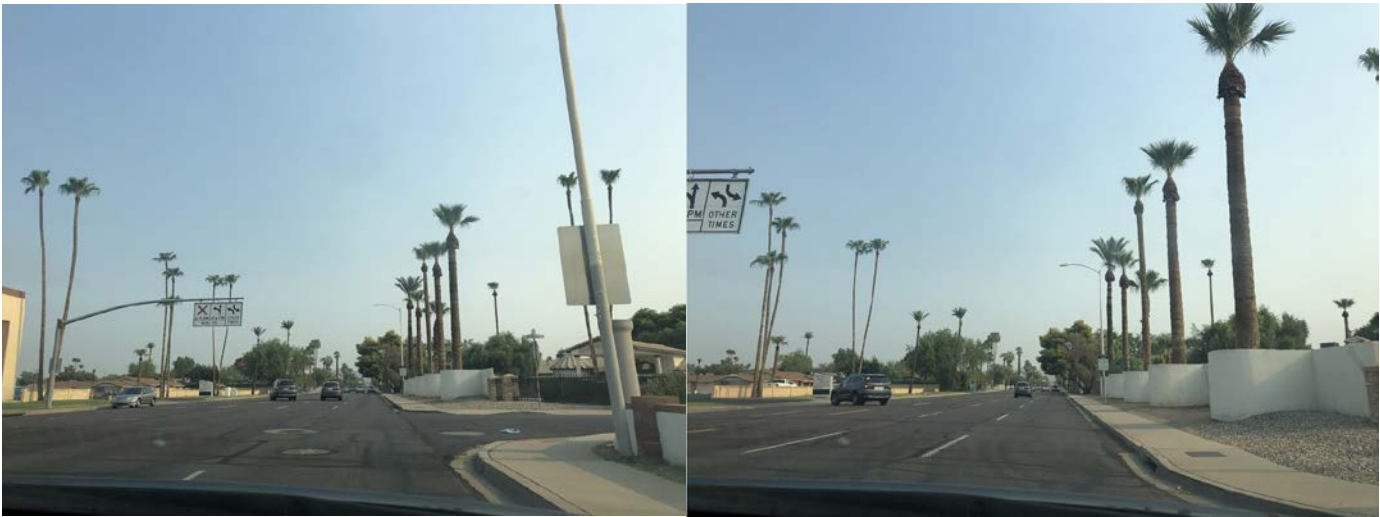
In the northern portion of the corridor (residential neighborhood area) drivers were more likely to turn left and cross the reversible lane during the AM peak hour when no left turns are permitted for northbound traffic.

**Photo 15 – Northbound on 7th Avenue between Missouri Avenue and Bethany Home Road:  
Vehicle Turning Left from Leftmost Non-Reverse Lane during AM Peak Hour to Enter Side Street**

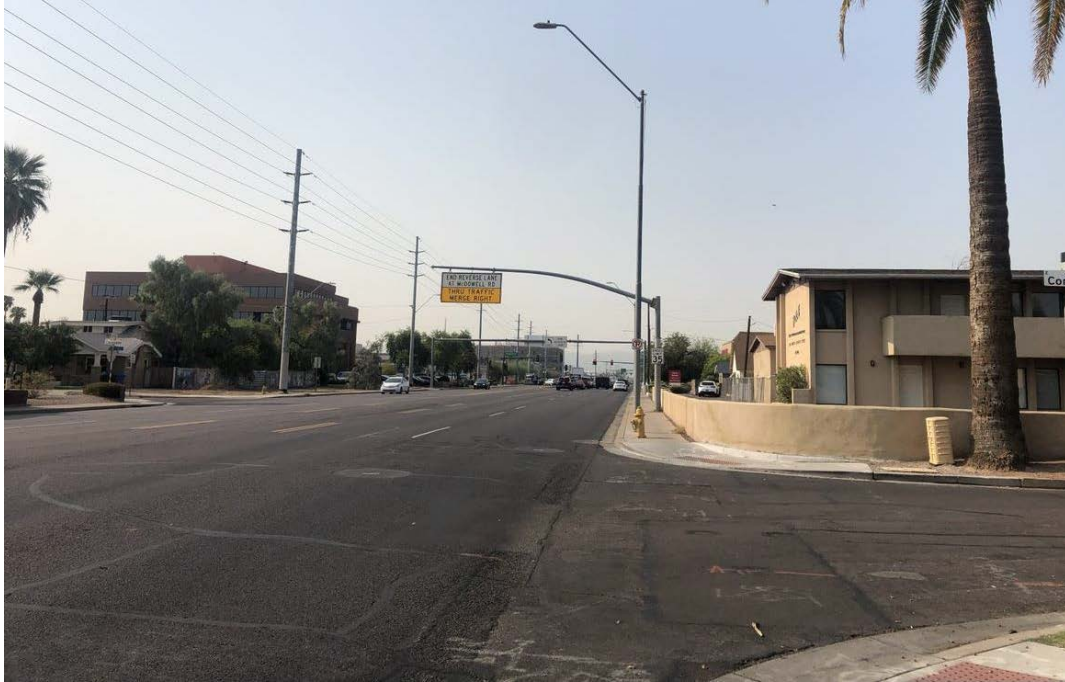
**Photo 16 – Southbound on 7th Street: Warning Sign for End of Reversible Lane**

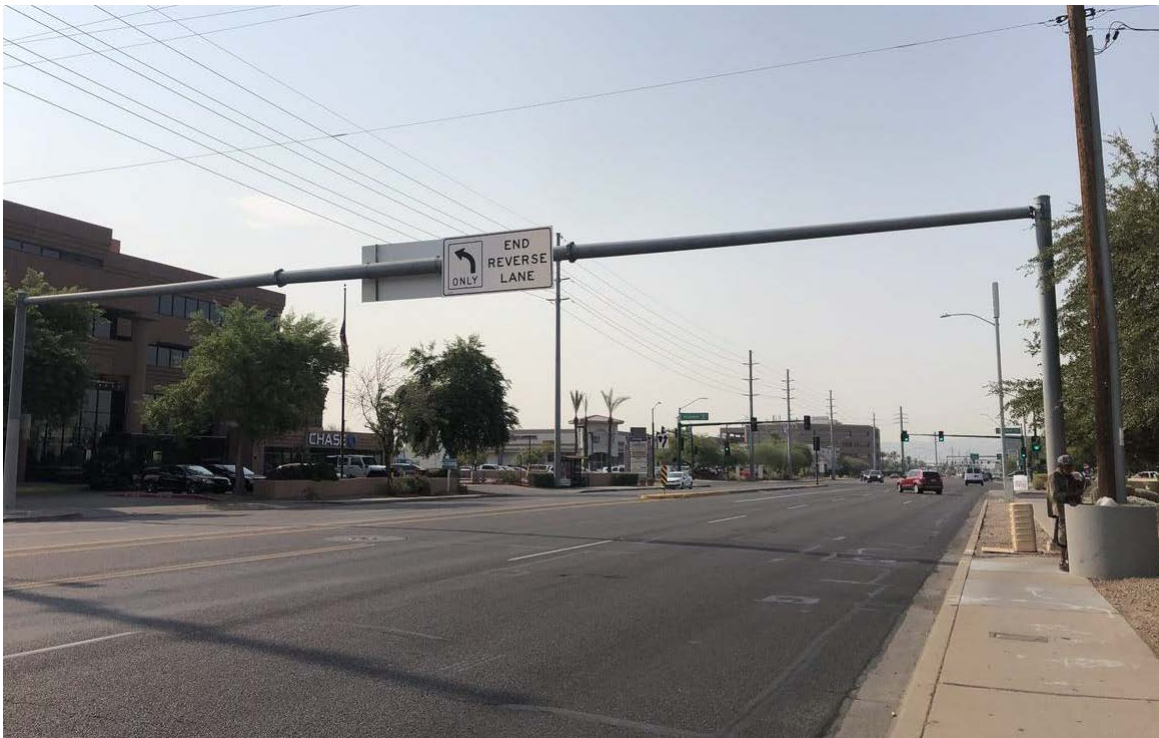
**Photo 17 – Southbound on 7th Street: End Reverse Lane Static Sign**

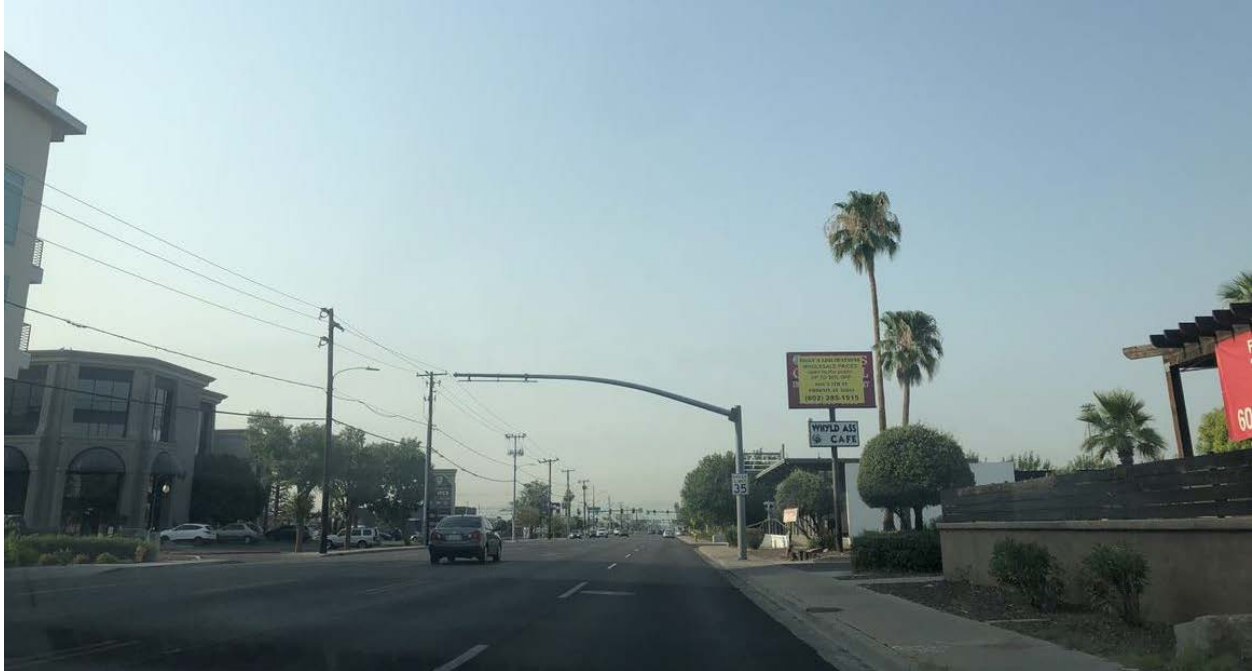
**Photo 18 – Southbound at Highland Avenue and Camelback Road:  
Missing Overhead Mast Arm Sign with No Construction**

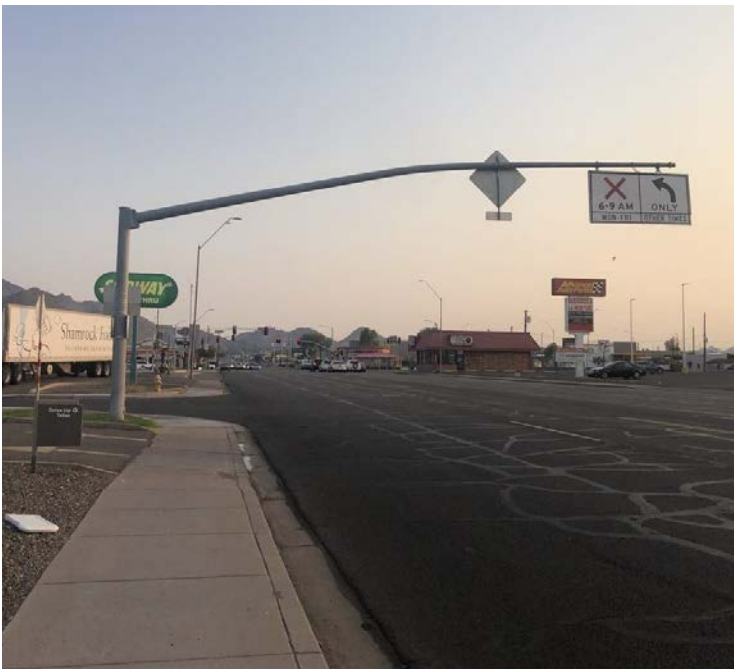
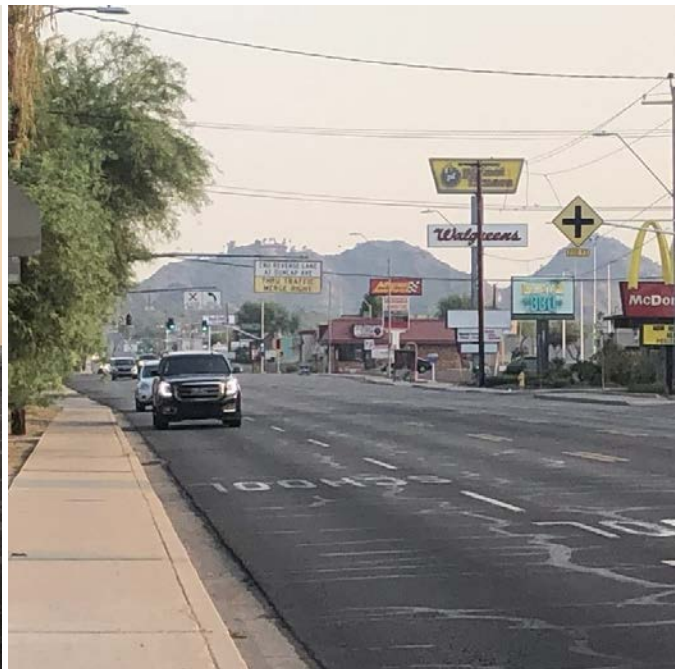
**Photo 19 – Northbound on 7th Street Between Alice Avenue and Dunlap Road:  
Change in Signage on Overhead Mast Arms**

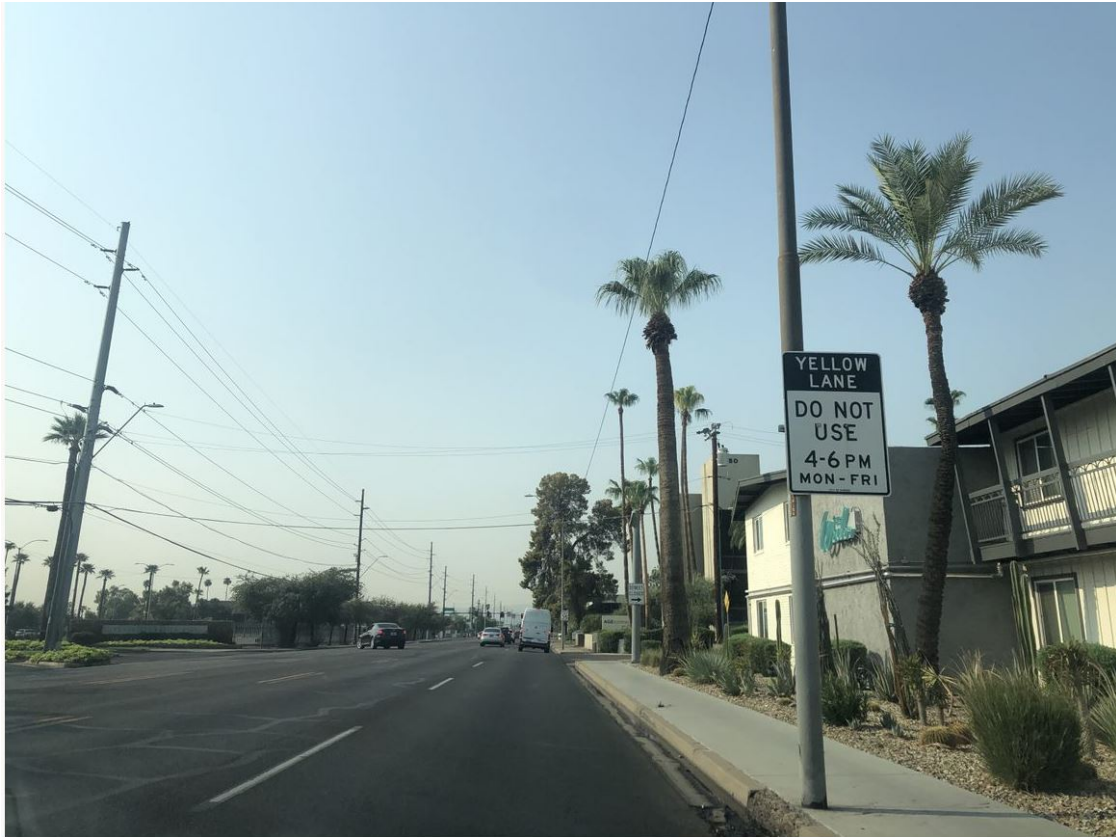
Driver confusion was exhibited during the initial time-frame of the reversible lane operation, as drivers traveling northbound were not aware that the double yellow dashed lane was a true southbound travel lane. Drivers aware of the reversible lane made prohibited left turns from the reversible lane and left-most northbound lane during AM reversible lane operations. These select vehicles were turning into businesses or driveways.

Photo 20 – Southbound on 7th Street Between Thomas Road and Osborn Road:  
Vehicle Turning Left During AM Peak Reversible Lane Operations
